THE ROLE OF GEOTEXTILE TUBE AS LOW-CRESTED BREAKWATERS IN RESTORING SEVERE BEACH EROSION PROBLEM AT PEBUAHAN BEACH IN BALI ISLAND

Dede M. Sulaiman¹ and Hendra Hidayat²

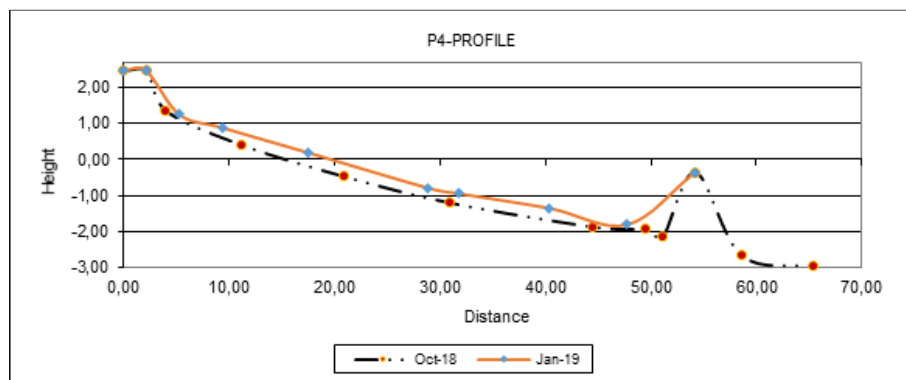
Figure 4. Cross section of P4 Profile

The P4 beach profile is a beach section behind the LCB structure. On the beach segment behind this LCB, the beach surface is higher, the accretion thickness is about 50 cm spread evenly, starting from the shoreline out to 45 m at a position 5 m behind the LCB. The greatest accretion or shallow siltation occurs just behind LCB, the sediment has been integrated with the LCB structure which is the Tombolo formation. Upon completion of LCB installation (7 October 2018) the water depth behind this structure is -2.5 m while the height of LCB after installation is 2.2 m. This P4 profile is at the left end (East) of LCB. The appearance of this P4 profile is shown in Figure 4 and net sedimentation along the beach is presented in Figure 5. Meanwhile the shoreline and tombolo formation are shown in Figures 6,7 and 8.

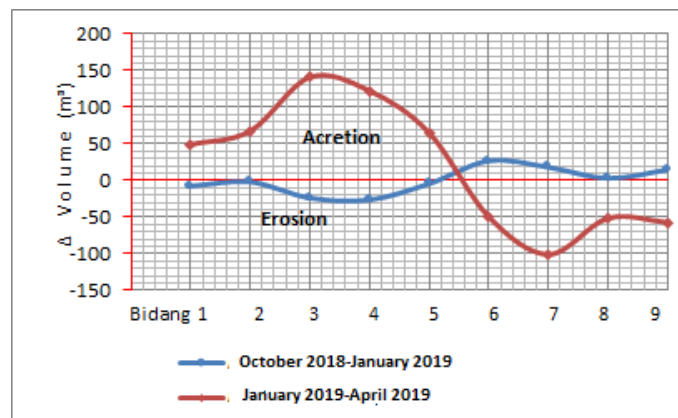
Figure 5. Erosion- accretion and net sedimentation behind LCB at Pebuhan Beach

The results of monitoring in January and April 2019 show sedimentation behind the structure as much as 185.8 m^3 . The sediment accumulation behind LCB consists of salient and tombolo formations, which are attached to the structure (Balai Pantai, 2019).

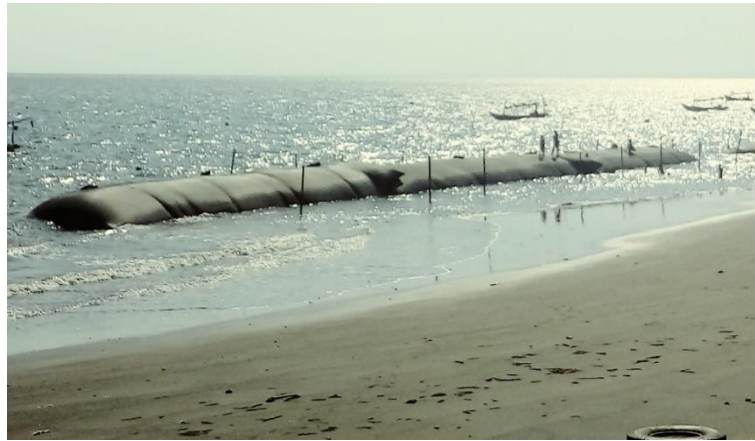
Figure 6. Shoreline condition after installation 7 October 2018

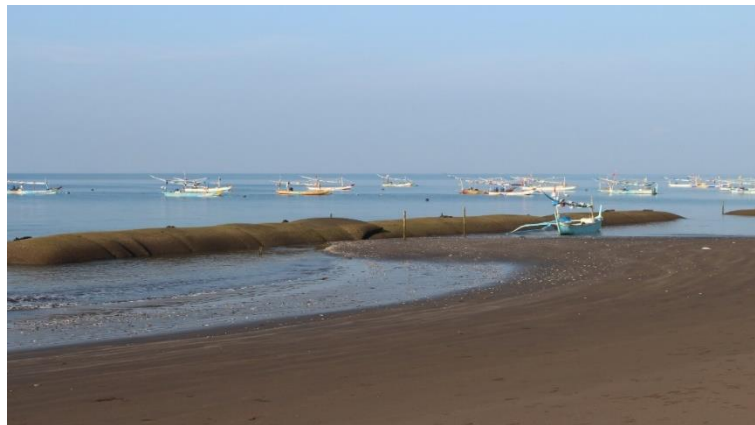
Figure 7. Shoreline condition after monitoring 7 January 2019

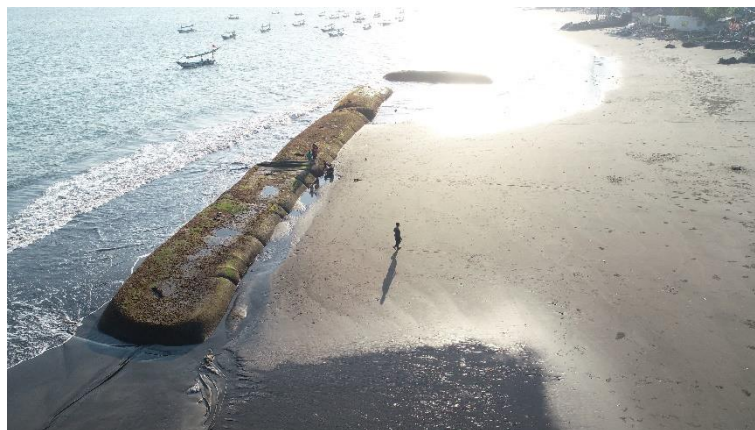
Figure 8. Shoreline condition of 1 August 2019
