TEST REPORT

No. : XMIN1811008335ML

Sample Name : ADJUSTABLE TILT ROOF MOUNT SYSTEM
Other Information : MG-AD-RL

Pull test:

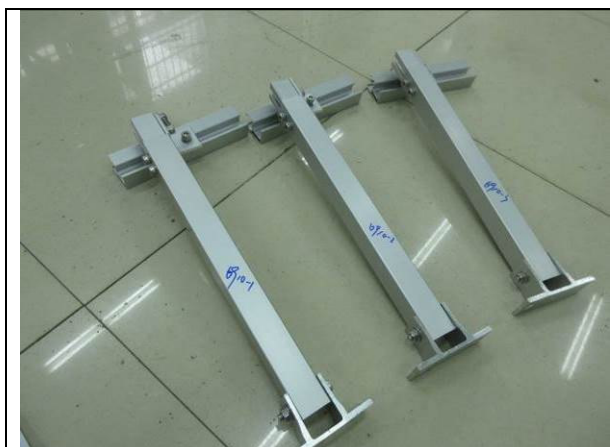
Photo 1: sample photo

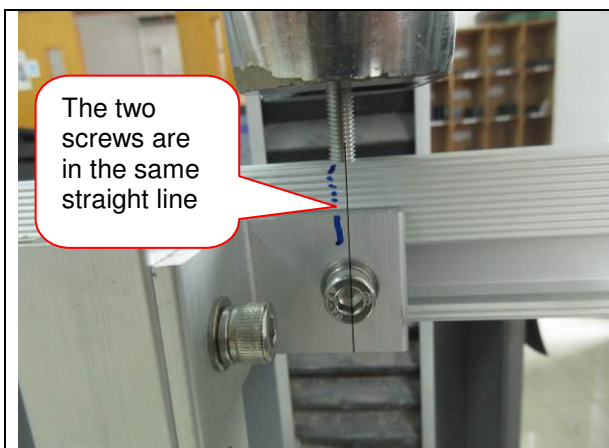
Photo 3: tensile test

Test method: According to the client's requirement, the base was fixed on the test machine with three M8 screws, and the locking force of the screws was 30N*m (see photo 2,3 and 4); Increase the tensile force as 5mm/min until the sample fail. Record the force.

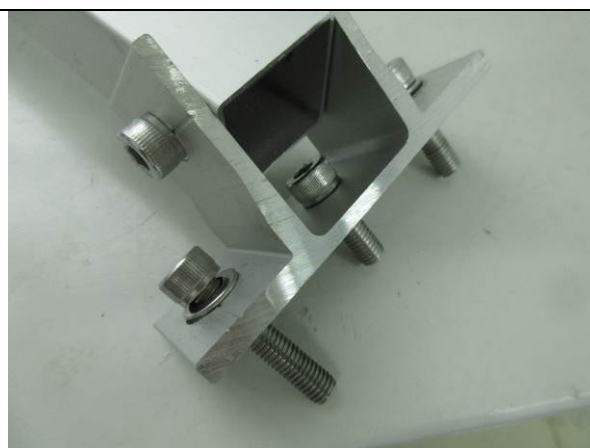
Photo 4: tensile test

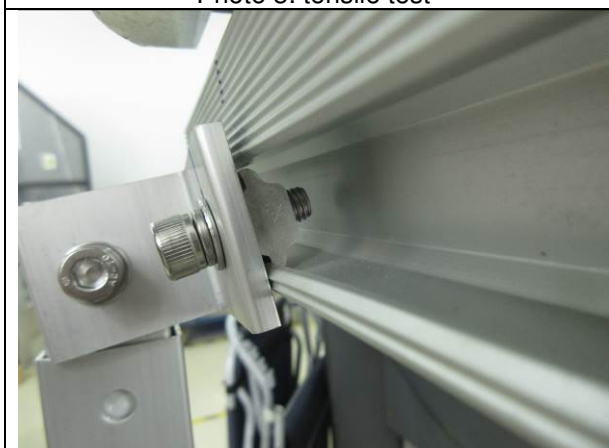
Photo 5: after tensile test (2#)

Sample No:	Result
2#	When the force increased to 2.75kN, the side rail was damaged (see photo 5)
3#	When the force increased to 2.93kN, the side rail was damaged (see photo 7)

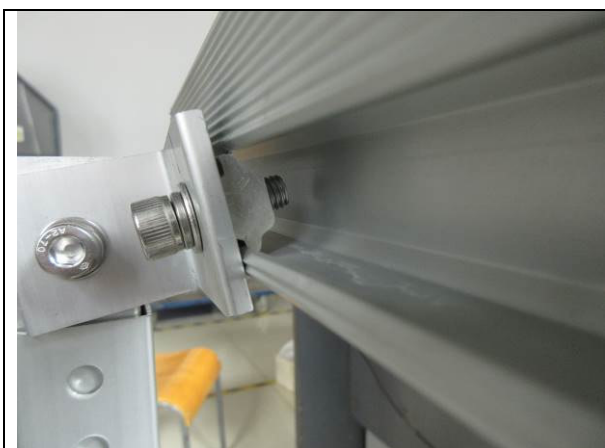
Photo 7: after tensile test (3#)

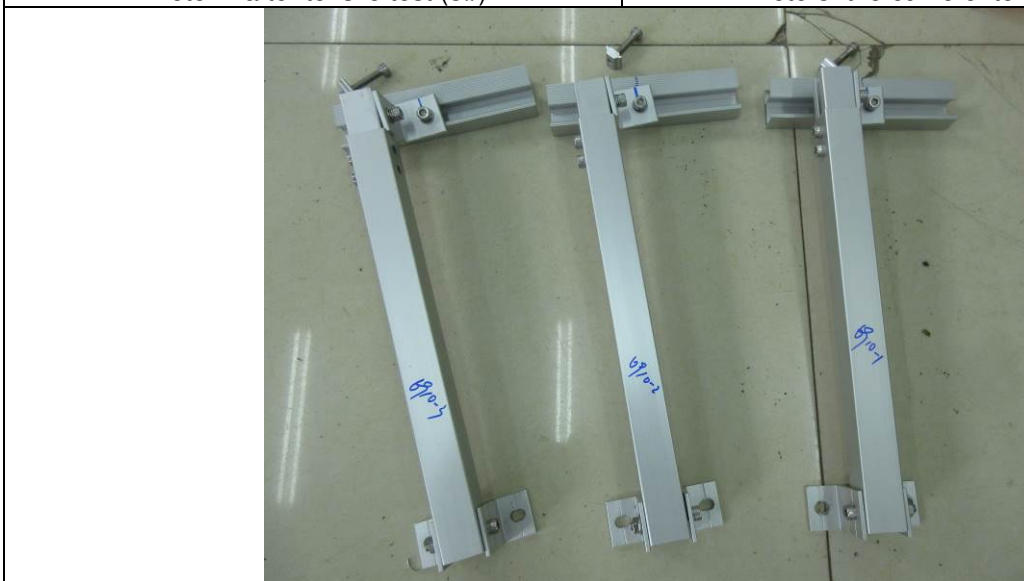
Photo 9: sample after the test
