TEST REPORT

No. : XMIN1810006911ML

Sample Name : ADJUSTABLE STAINLESS STEEL TILE HOOK
Other Information : MG-SS-ATH-02

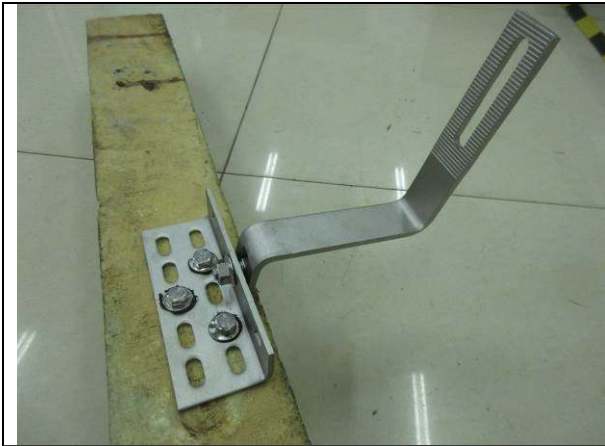
Photo 1: sample photo

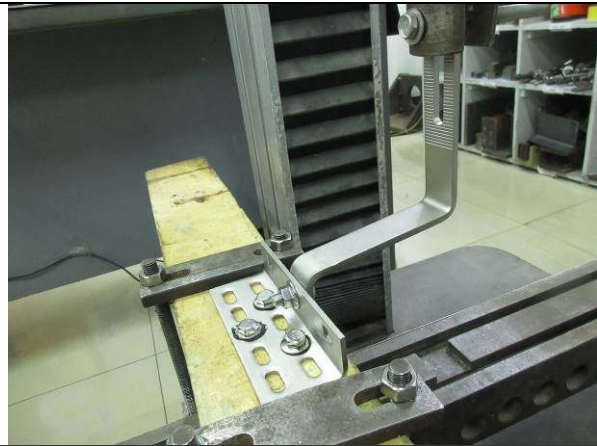
Test method: According to the client's requirement, the base plate of the hook was fixed to the wood with three 8*100 wood screws, while the wood was fixed to the test bench (see photo 2); Increase the tensile force as 5mm/min until the hook has obvious deformation. Record the force.

Photo 2: tensile test

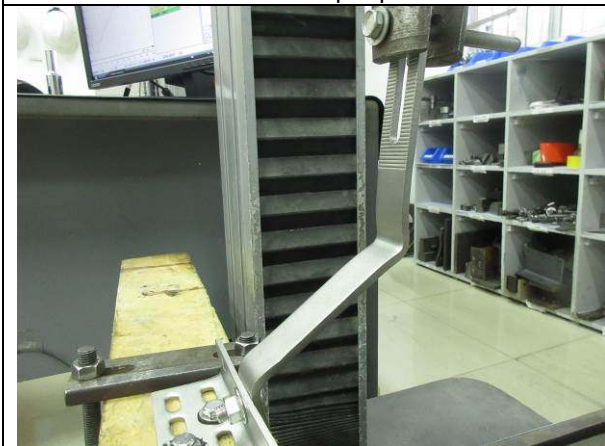
Test result: When the force increased to 4.91kN, hook presented obvious deformation (see photo 3).

Photo 3: after tensile test (obvious deformation)

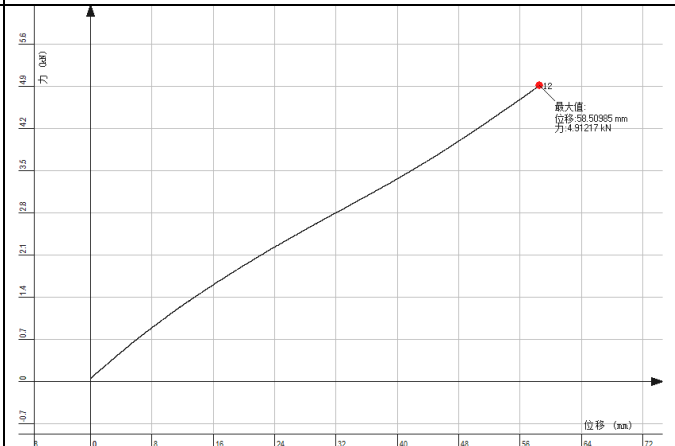
Photo 4: the curve of tension test

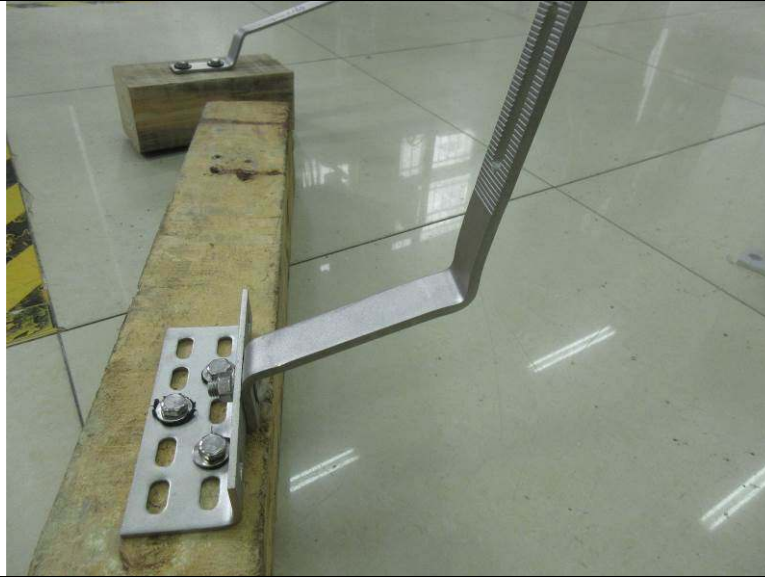
Photo 5: sample after the test
