## TEST REPORT

No. : XMIN1810006912ML

Sample Name : STAINLESS STEEL FLAT TILE HOOK  
Other Information : MG-SS-FTH-01

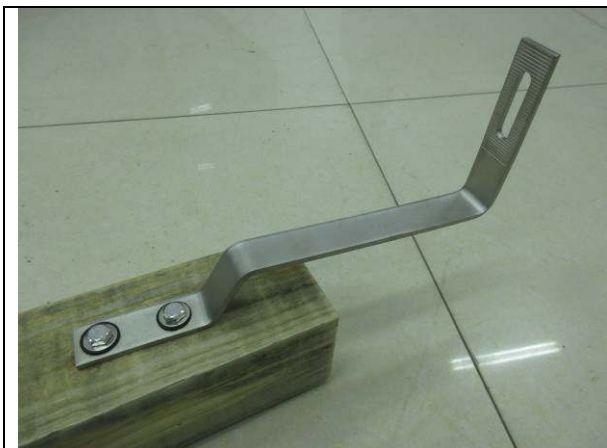
Photo 1: sample photo

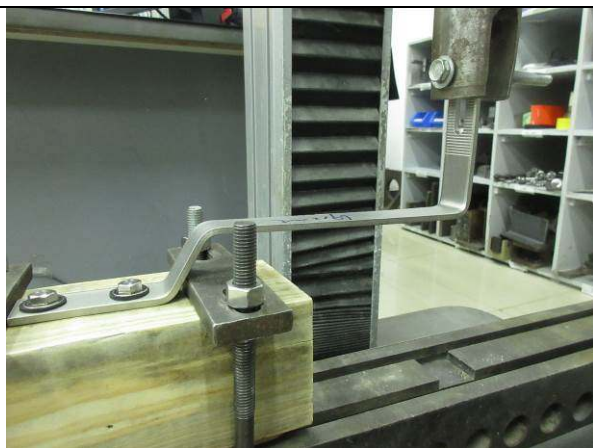
Photo 2: tensile test

Test method: According to the client's requirement, the base plate of the hook was fixed to the wood with two 8\*100 wood screws, while the wood was fixed to the test bench (see photo 2); Increase the tensile force as 5mm/min until the hook has obvious deformation. Record the force.

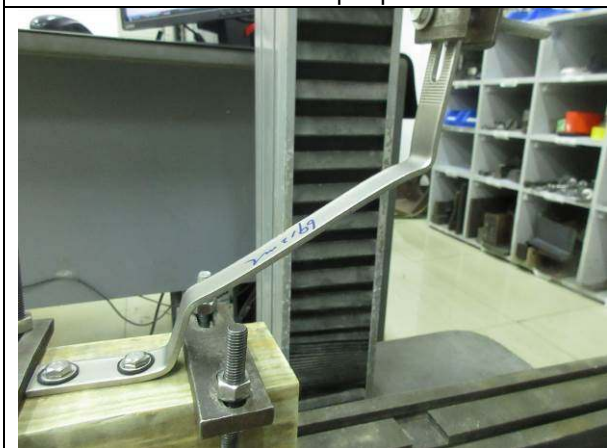
Photo 3: after tensile test (obvious deformation)

Test result: When the force increased to 2.60kN, hook presented obvious deformation (see photo 3).

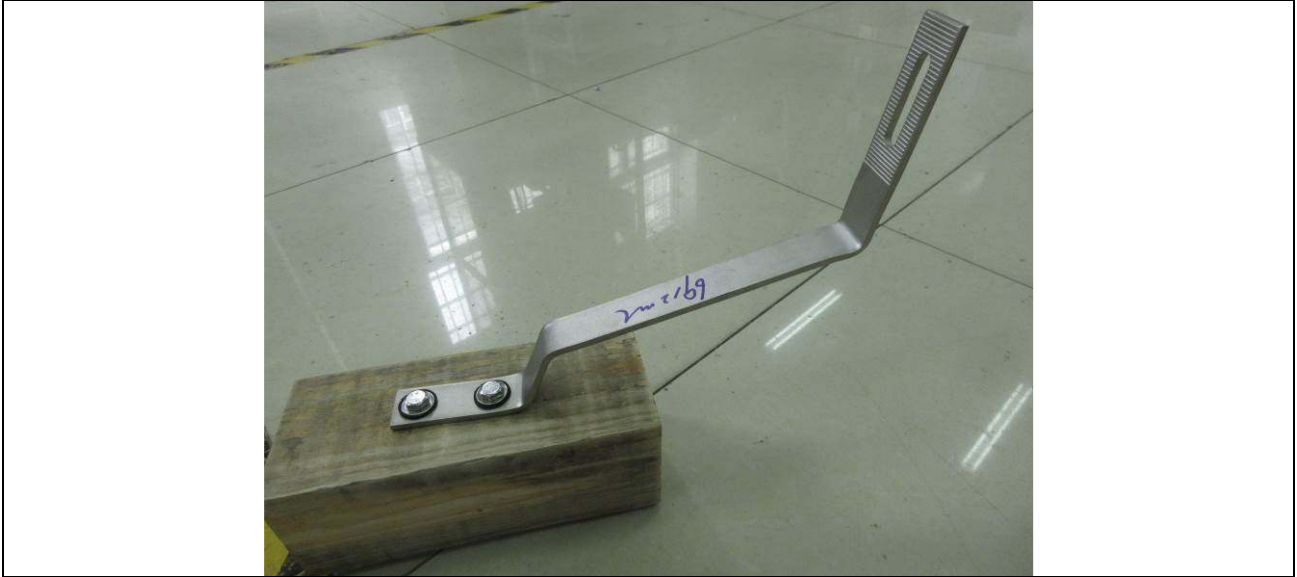
Photo 5: sample after the test
