## TEST REPORT

No. : XMIN2405000961CM02\_EN

Sample Name : GMT PALLET  
Manufacturer : YINAN JINTAI GMT PALLET CO. , LTD  
Material : Fiber glass

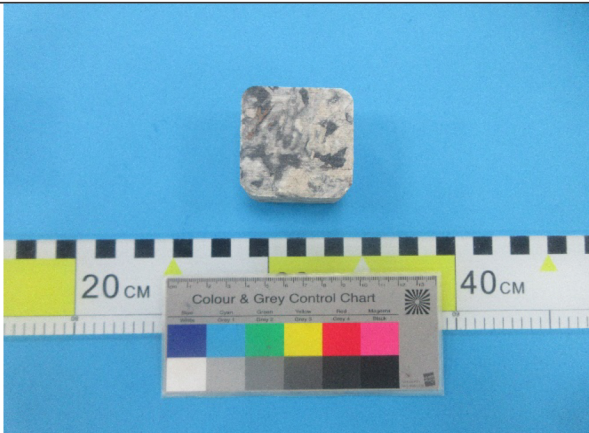
Before Test-Sample A

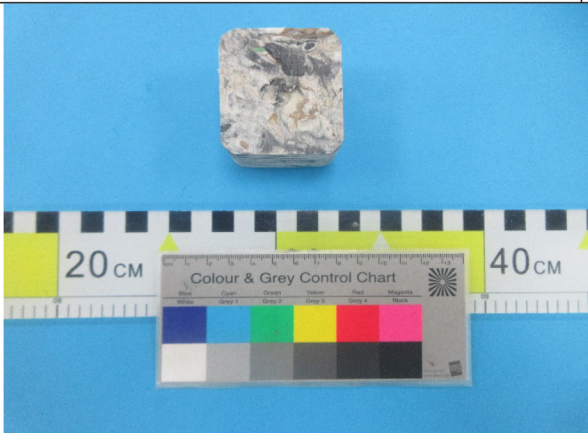
After Test-Sample A

Test Item	Test Result
Striker Impacted by a Falling Weight	Mean failure energy: >35J

Note: Test result exceeded the upper limit of the tester.
