Allen Bradley 1756-RM2

ControlLogix Enhanced Redundancy System, Revision 20.058_kit2

Redundancy Module Catalog Numbers
1756-RM, 1756-RMXT, 1756-RM2, 1756-RM2XT

Product Release Notes

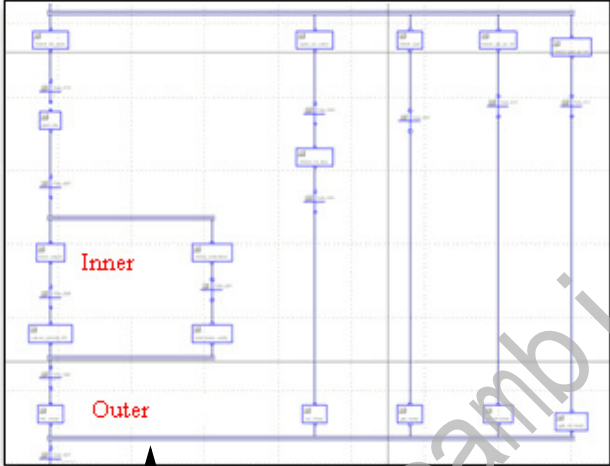
Cat. No./System Component	Enhanced Redundancy System Revision	Description
1756-L61 1756-L62 1756-L63 1756-L63XT 1756-L64 1756-L65 1756-L71 1756-L72 1756-L73 1756-L73XT 1756-L74 1756-L75	20.054	<p>CORRECTED: An anomaly can occur when you nest simultaneous branches in a sequential function chart (SFC) routine as shown in this graphic.</p>

<p style="text-align: center;">Bottom-most Steps</p> <p>During normal operations, the logic does not step out of a simultaneous branch until all incoming legs have reached their bottom-most step. In the example that is shown, the logic does not step out of the Outer simultaneous branch until the left-most leg has stepped out of the Inner simultaneous branch.</p> <p>The first time through the SFC routine, the application works as expected. On subsequent scans, however, the chart steps out of the Outer simultaneous branch even though the left leg has not reached the Inner simultaneous branch yet.</p> <p>This behavior occurs because the information in the bottom step, that is, the step next to the word Outer, remains from the previous scan. This stale information incorrectly causes the transition to move on as if the left leg is at the bottom step when it actually is not.</p> <p>To work around this anomaly, confirm that all incoming legs have reached their bottom steps in the transition. You can check the .x bits to make sure that the bottom-most step of each converging leg is active before allowing the chart to advance. This check can be added to the transition logic already present.</p> <p>For example, the steps in the following expression are the bottom steps (see the previous graphic) of the incoming legs. Each step has a timer. The transition does not move on until all step timers have reached their preset value.</p> <p>The expression can be modified to be sure that those steps are truly active. This expression is the original expression:</p> <pre>// Unit is ready to Transition Step1_ready.dn and Step2_ready.dn and Step3_ready.dn and Step4_ready.dn and Step5_ready.dn</pre> <p>This expression is the modified expression to work around this anomaly.</p> <pre>// Unit is ready to Transition Step1_ready.x and Step2_ready.x and Step3_ready.x and Step4_ready.x and Step5_ready.x and Step1_ready.dn and Step2_ready.dn and Step3_ready.dn and Step4_ready.dn and Step5_ready.dn</pre> <p>IMPORTANT: The x bit is cleared when the chart transitions out of a step.</p> <p>If you add this check to the condition, it forces the engine to wait until all of those steps are genuinely active before advancing out of the simultaneous branch.</p> <p style="text-align: right;">Lgx00118189, Lgx00116506</p>

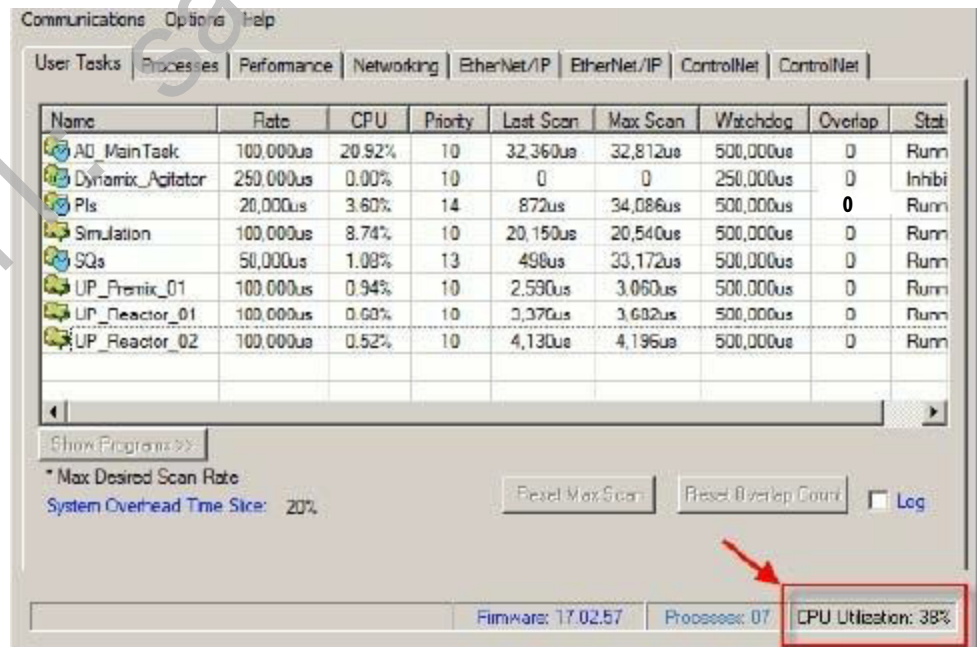
1. Monitor the Max Scan Time for each task while the redundant chassis pair is synchronized.
2. Set the Watchdog times for each task to 3 times the Max Scan Time.
3. To configure each Task Period, use the Logix 5000™ Task Monitor Tool.⁽¹⁾
 - Adjust the Task periods of each so that the maximum scan time is less than 80% of the task period rate.

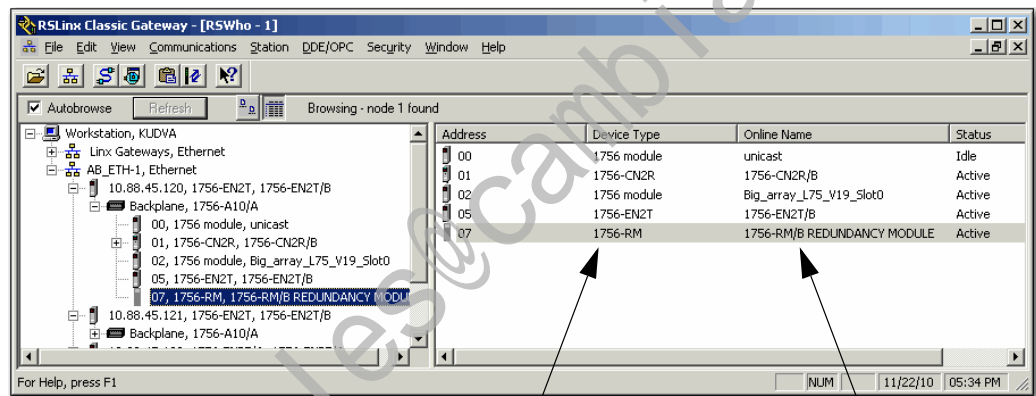
Generic 1756-RM Redundancy
Module Device Type

We recommend that you use the EDS file for redundancy modules that is included with the enhanced redundancy system, revision 20.054_kit1 firmware bundle. With the new EDS file, the RSWho software Device Type column shows a generic 1756-RM device type, as shown in this graphic.

1756-RM/B Redundancy
Module Indication

1756-RM2/B modules and 1756-RM2XT/B modules appear as series A modules in the Device Type column of an RSWho browse screen. This condition occurs if you use the EDS files available with enhanced redundancy system, revision 16.081, in an enhanced redundancy system, firmware revision 20.054.

In this case, use the information in the Online Name column to identify the series level of your redundancy modules. The information in the Online Name column is accurate.

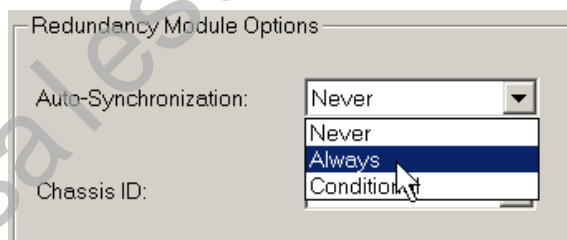
1. Using the Redundancy Module Configuration Tool (RMCT):
 - a. Set Auto-synchronization to Never.
 - b. Disqualify the redundant chassis pair (if not already disqualified).
2. Remove the module from the secondary chassis and replace it with the new module.
3. If applicable, update the module firmware by using ControlFLASH.
4. In the RMCT, from the Auto-Synchronization pull-down menu, choose your preferred method.

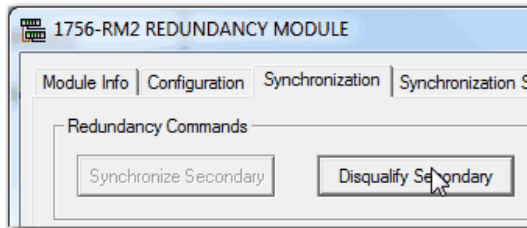
9. On the Synchronization tab, click Disqualify Secondary.

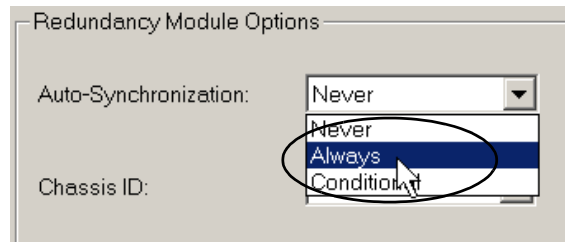
24. On the Configuration tab, from the Auto-Synchronization pull-down menu, choose Always.

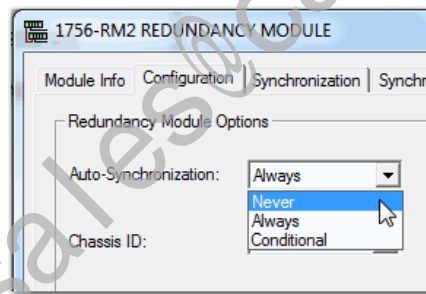
- a. Start RSLinx Classic Software.
 - b. Select Communications and choose RSWho.
 - c. Open the branches of your network until you find the 1756-RM or 1756-RM2 module in the primary chassis.
 - d. Right-click the 1756-RM or 1756-RM2 module, and choose Module Configuration.
8. On the Configuration tab, from the Auto-Synchronization pull-down menu, choose Never.

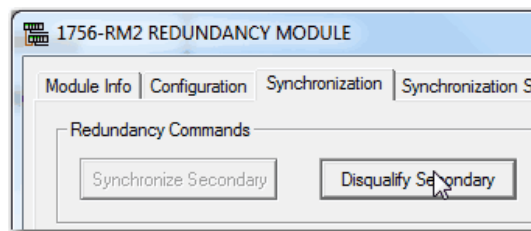
9. Click Apply and then Yes.
10. On the Synchronization tab, click Disqualify Secondary and then click Yes.

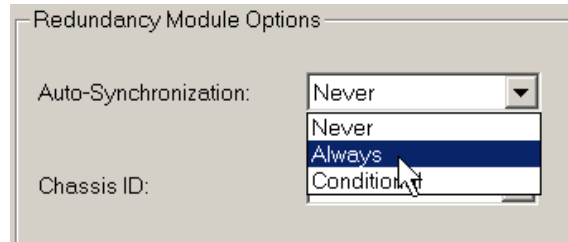
23. In the RMCT, from the Auto-Synchronization pull-down menu, choose your preferred method.

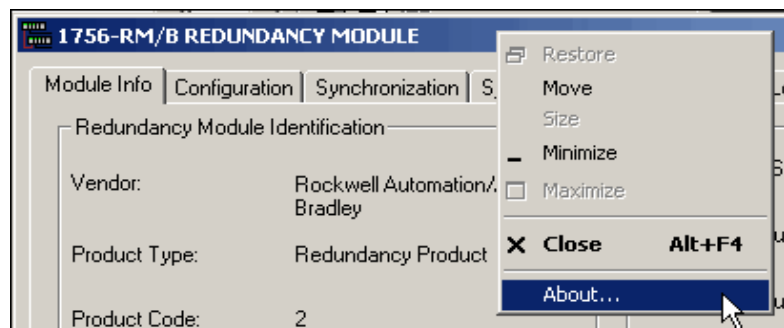
4. Right-click the title bar and choose About.

The About dialog box opens and indicates the RMCT version.

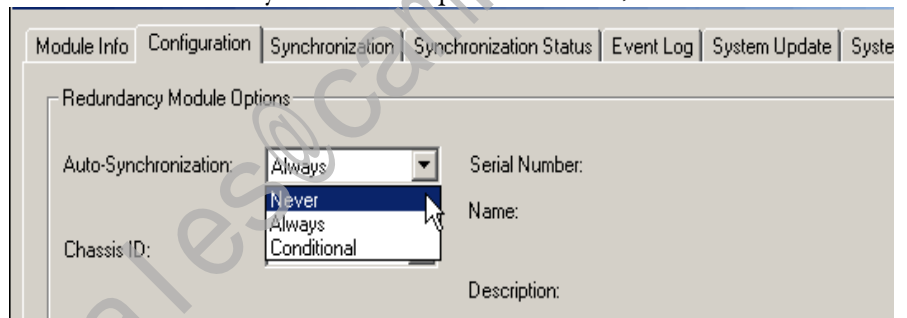
- Click the Configuration tab in the RMCT.
- From the Auto-Synchronization pull-down menu, choose Never.

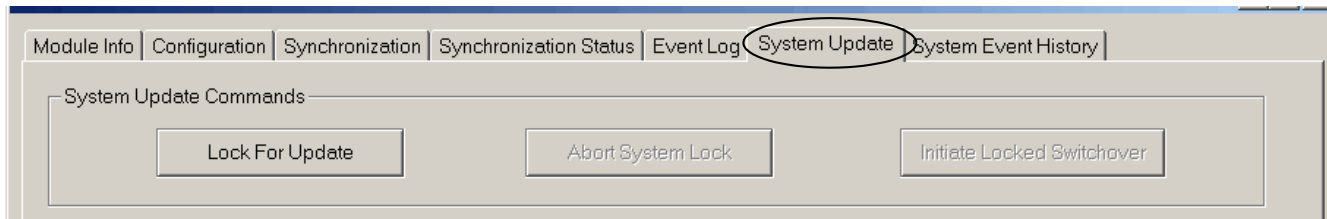
2. Click the System Update tab.

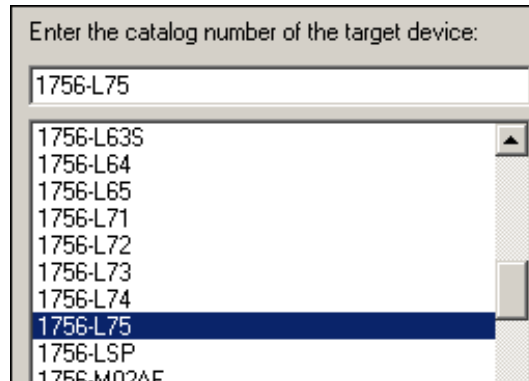
4. Select the module catalog number and click Next.

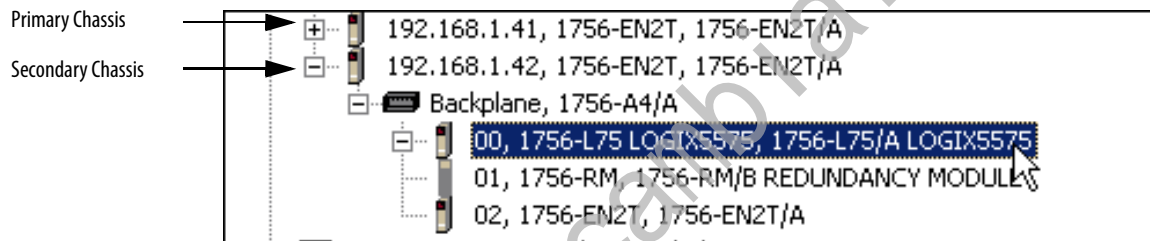
5. Browse to the module and select it.

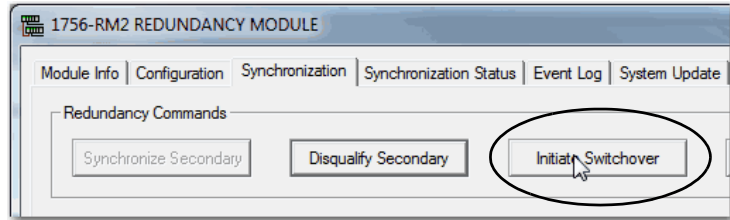
3. Initiate a switchover.

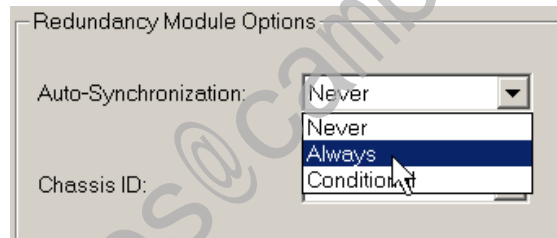
4. In the new secondary, set the rotary switches back to the original configuration.
5. Repeat this process for all Ethernet modules that need the rotary switches set back to 2...254.
6. From the Auto-Synchronization pull-down menu, choose the frequency that suits your application.

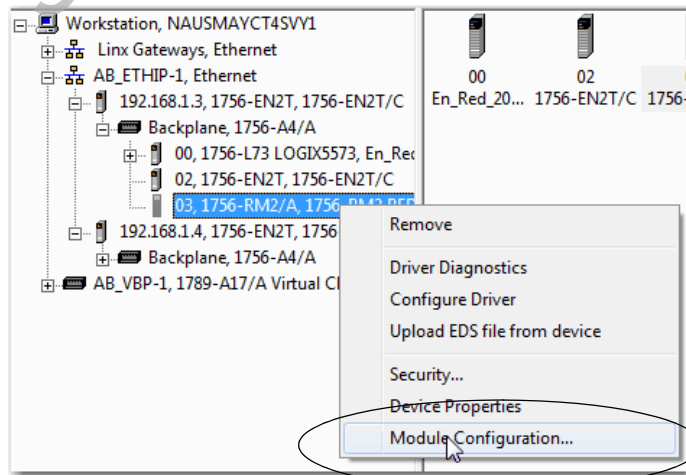
1. Open RSLinx Classic software and browse to the redundancy module.
2. Right-click the redundancy module in the primary chassis and choose Module Configuration.

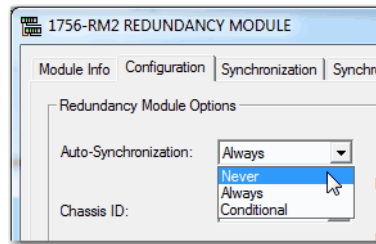
3. Verify that the chassis are synchronized.
4. On the Configuration, choose Never from the Auto-Synchronization pull-down menu.

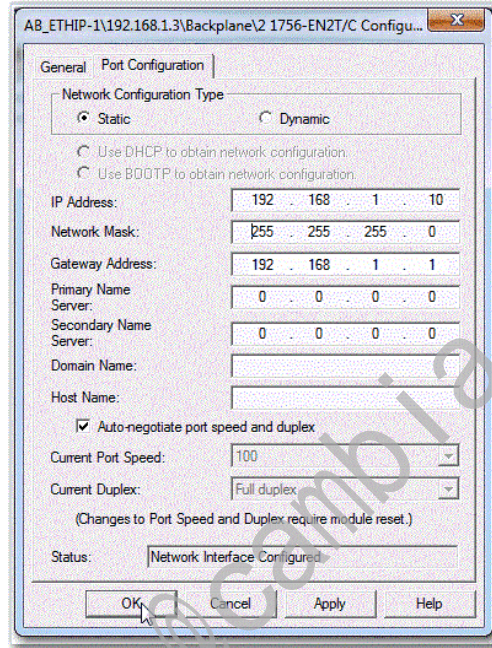
- b. On the Port Configuration tab, enter the desired IP address, Network Mask (if not entered automatically), and click OK.

This example uses the values in the following screen capture.

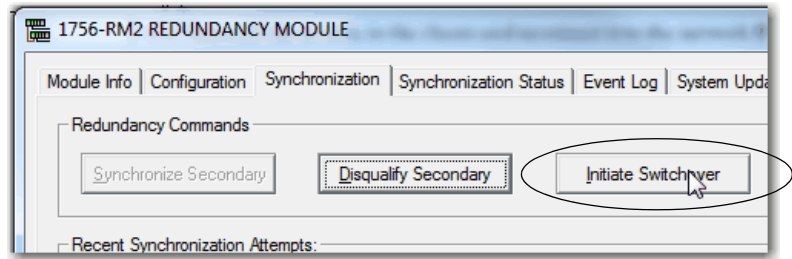
14. On the same tab, click Initiate Switchover to switch the primary and secondary chassis in the system.

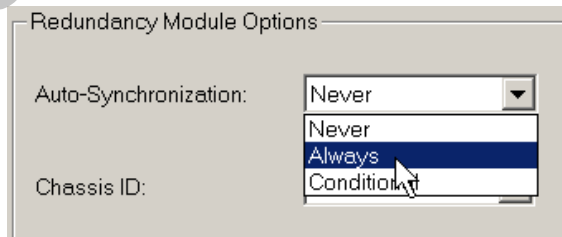
18. After the module resets, remove it again.
19. Set the rotary switches on the secondary module to the desired IP address.
20. Reinstall the module in the chassis and reconnect it to the network.
Any Duplicate IP address errors that existed previously are no longer present.
21. In the RMCT, from the Auto-Synchronization pull-down menu, choose your preferred method.

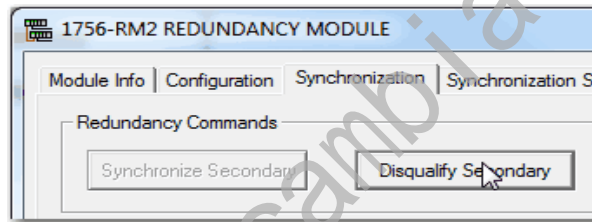
- Click Apply, and then click Yes.
- On the Synchronization tab, click Disqualify Secondary.

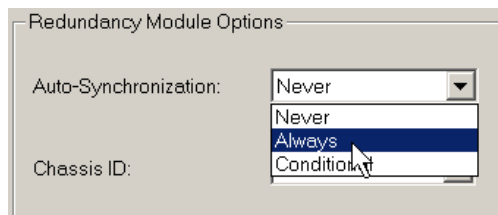
- In the RMCT, from the Auto-Synchronization pull-down menu, choose your preferred method.

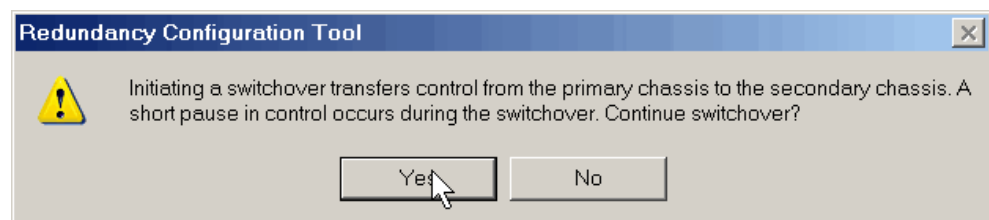
The Redundancy Configuration Tool dialog box opens.

11. Click Yes.
