PACSystems* RX7i

IC698CPE010/CPE020

Central Processing Unit

GFK-2244AG

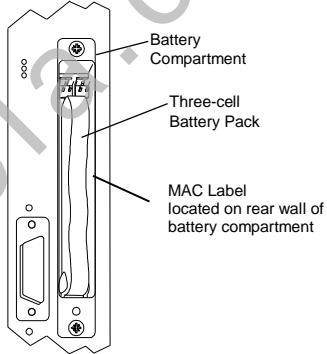
| Subject | Description |
|--|---|
| <p>MAC address</p> | <p>A label on the rear wall inside the CPU's battery compartment identifies the MAC address assigned to the CPU's embedded Ethernet Interface.</p> |
