## IMPORTANT PRODUCT INFORMATION

**Product:**     **IC693DSM302 Module (“DSM302”)**  
                  IC693DSM302AD  
                  Firmware Version 1.30

The DSM302 Module is a two-axis motion control module, which is highly integrated with the logic solving and communications functions of the IC693 PLC. Two primary control loop configurations are provided: Standard mode and Follower mode. The basic capabilities of the DSM302 are described below:

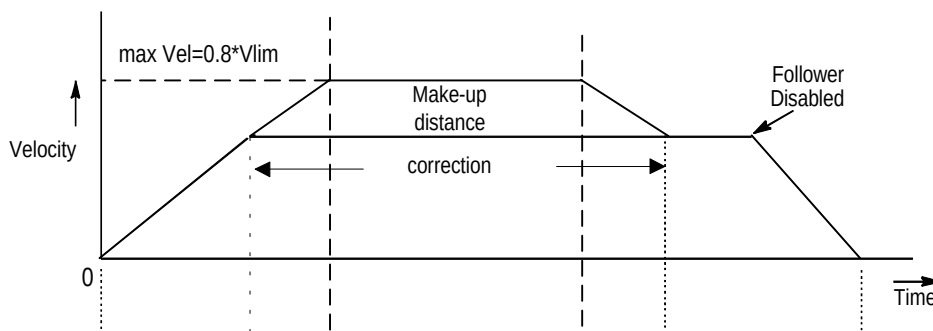
The figure below shows the velocity profile during the follower ramp cycle. *Note: The enhanced follower make-up may affect existing applications that use the old follower make-up feature.*

The Follower Axis Ramp Control Function is enhanced in DSM firmware release 1.30. The enhancement improves motion smoothness. Prior to this release, when the follower was active and the master in motion, the acceleration/deceleration control during the make-up correction phase was not controlled by a velocity profile. This could cause unwanted machine shock. The enhanced method uses a trapezoidal velocity profile to address this problem. During the entire make-up correction phase, the acceleration/deceleration is limited to the jog acceleration value. Also during the correction, the velocity is not allowed to exceed the maximum. Appropriate warning/error codes notify the user about abnormal operation (see error table below).
