Service Manual of PANA 9600S Full-automatic Nucleic Acid Workstation

Xi'an Tianlong Science and Technology Co., Ltd.

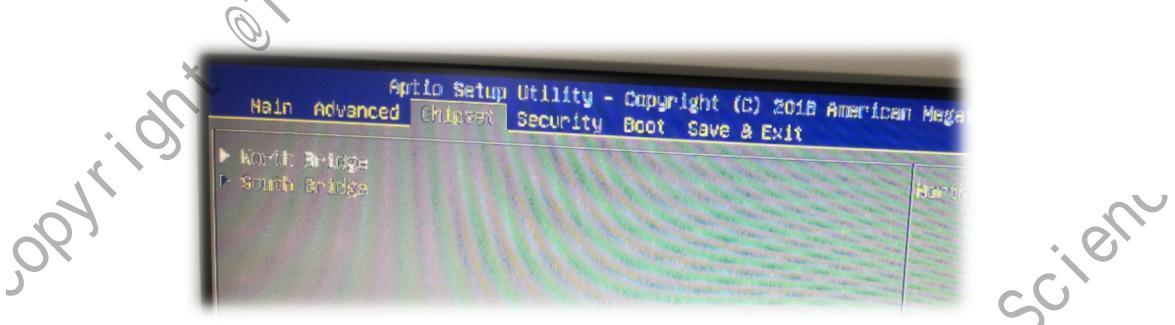
Step 2: Power on the instrument, press the "Delete" key on the keyboard to enter the Boot interface, and ,09×ri select "Northbridge" in the "Chipset" column;

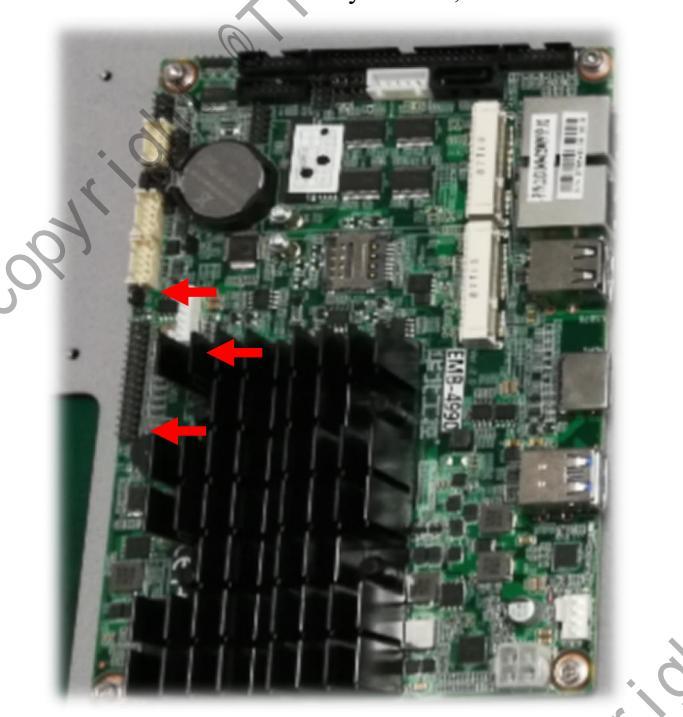
If the setting is normal, it is necessary to continue the troubleshooting; Step 4: Disassemble the instrument to the position of industrial control board. See "1.10 Disassembly Process" for the disassembly method, and confirm whether the terminal of the screen wire is loose; ,084<sup>r</sup>

If the wire is loose, confirm that the instrument is normal after re-plugging If the wire is not loose, it is necessary to continue the troubleshooting

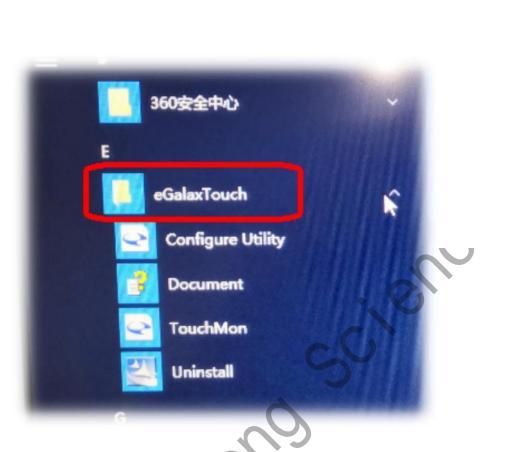
Troubleshooting process Step 1: After the instrument is powered on, find "eGalaxTouch" in the program and run the screen sopyrios calibration program;

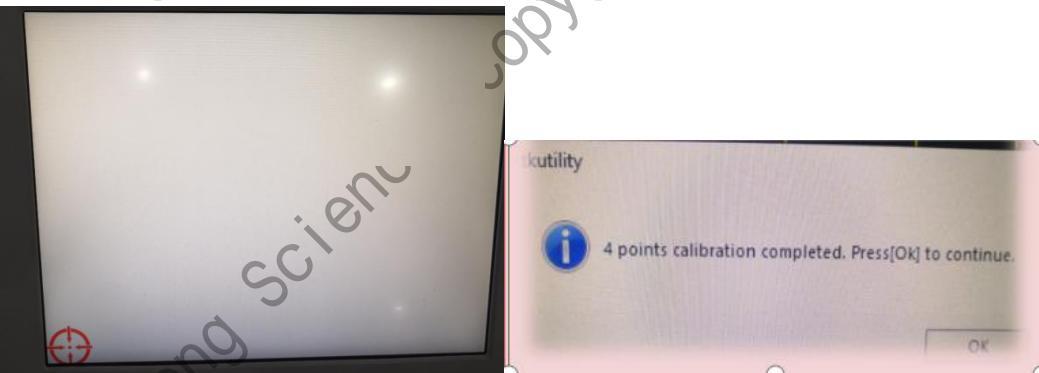
Step 3: According to the prompts on the screen, click the center of the target to complete the calibration. After the completion, click Ok as shown by the prompt.

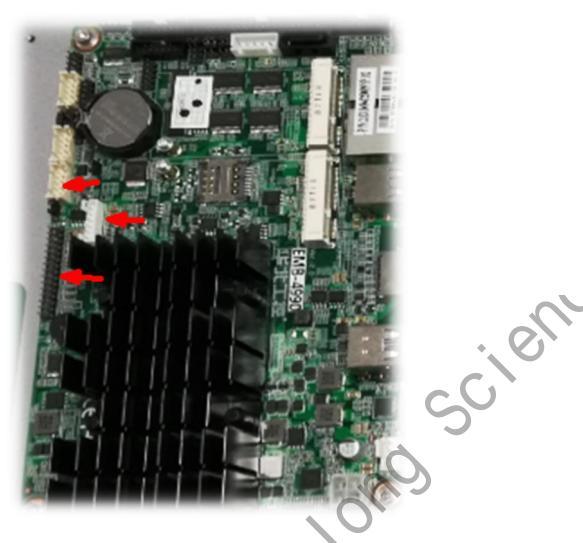
aniono Step 4: Disassemble the instrument to the position of industrial control board. See "1.10 Disassembly Process" for the disassembly method, and confirm whether the terminal of the screen wire is loose;

If the wire is loose, confirm that the instrument is normal after re-plugging If the wire is not loose, it is necessary to continue the troubleshooting

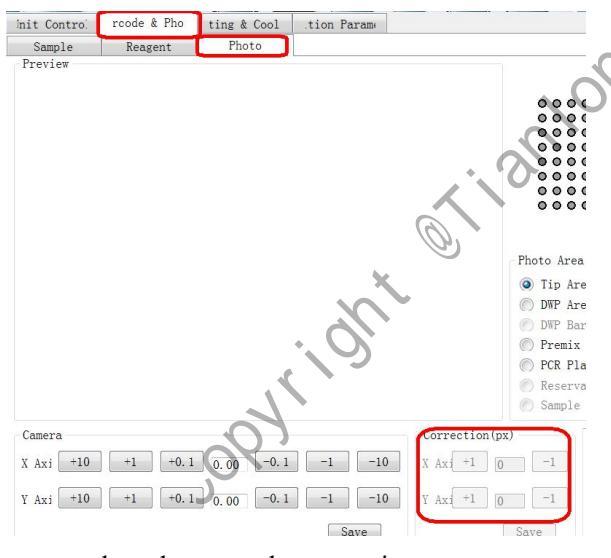
Step 2: Enter the engineering software and confirm the correction parameters in the "Photographing" interface in the "Barcode Photographing" column;

If all are 0, query the factory records and re-save the correction parameters If it is normal, it is necessary to continue the troubleshooting Step 3: Re-debug camera parameters in the engineering software interface

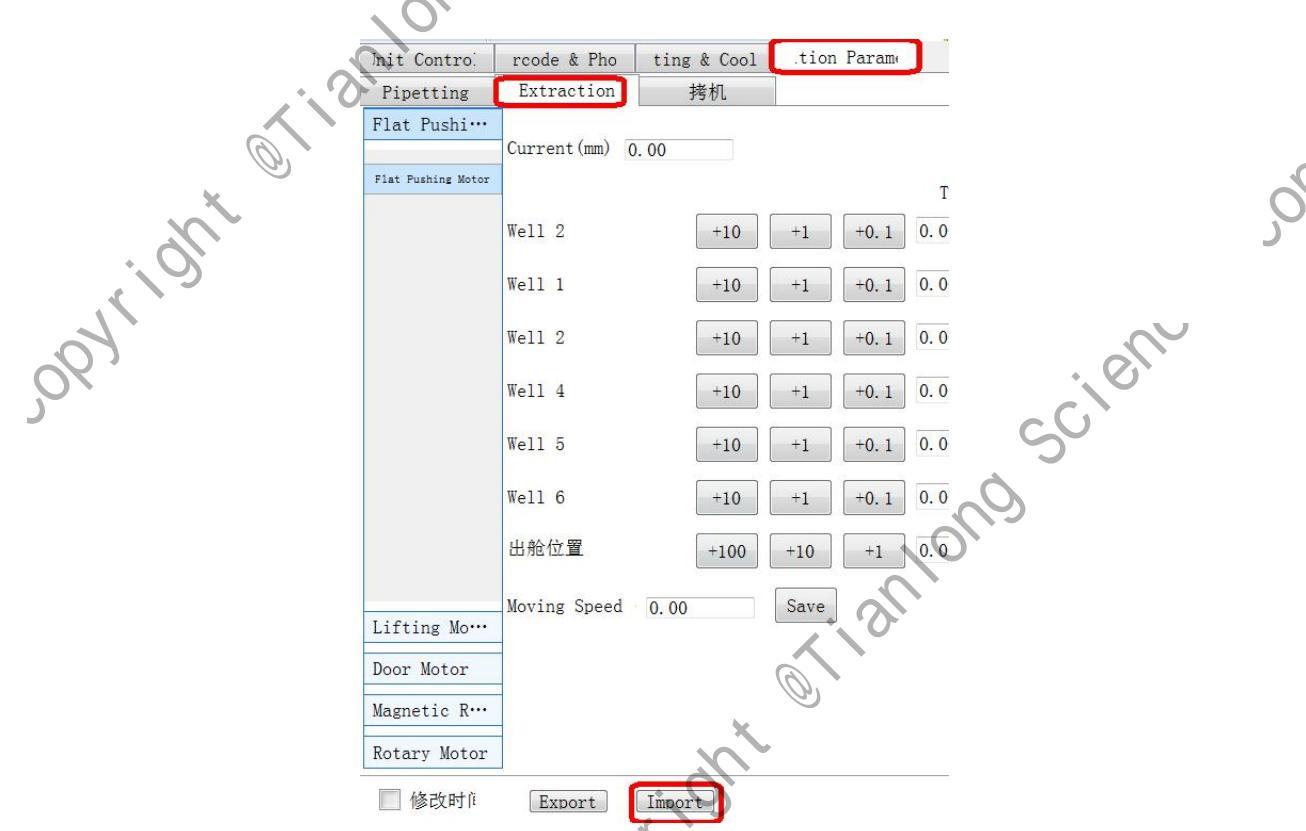
Step 2: Enter the engineering software, select "Import" in the "Extraction" interface in the "Position Parameter" column, import the backup parameters in the D disk of the instrument, and confirm whether the parameters such as forward and backward pushing and loading are correct;

If the parameters are different, and the instrument parameters are abnormal, import them again If the parameters are the same, it is necessary to continue troubleshooting Step 3: Adjust all parameters of the extraction module

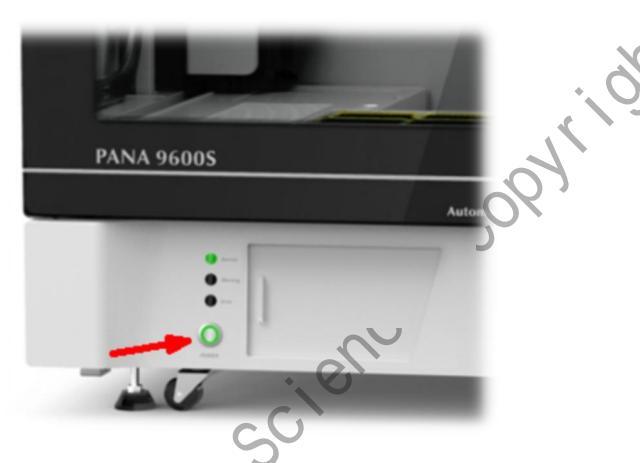
Step 1: After powering on, first confirm whether the power button light is always on;

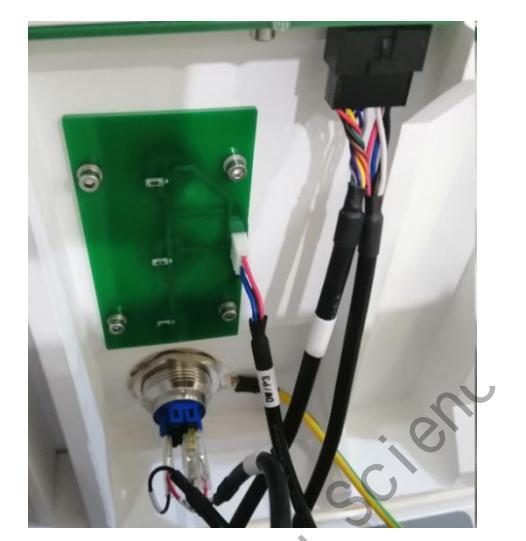
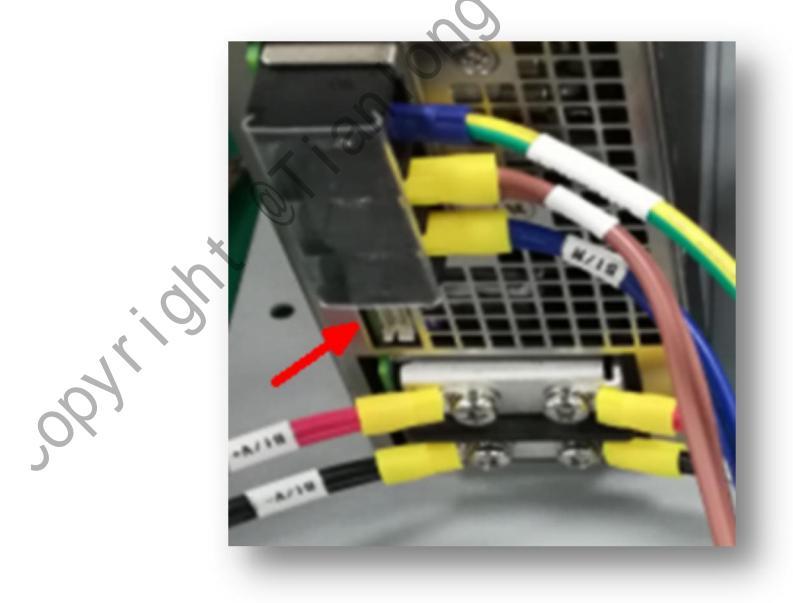
If the power button light is not on, remove the left shell and confirm whether the power

indicator lights (2 green lights) are on normally.

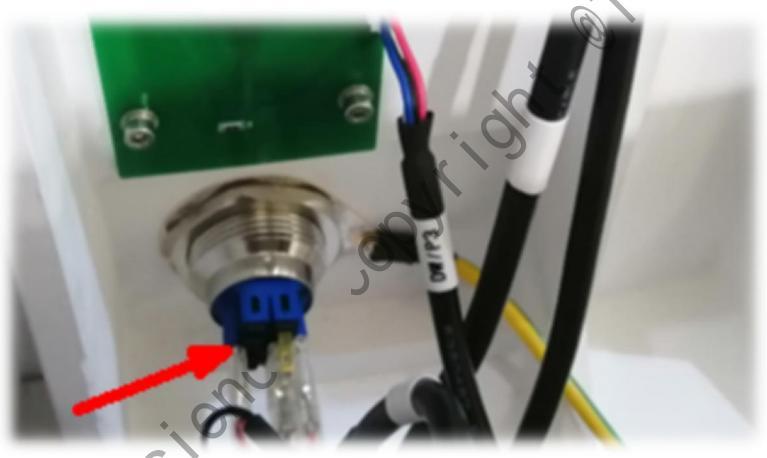
onoscient Step 3: If the power supply is on normally, confirm whether the connecting line of the power button light is loose or not plugged properly, or whether the switch material is abnormal;

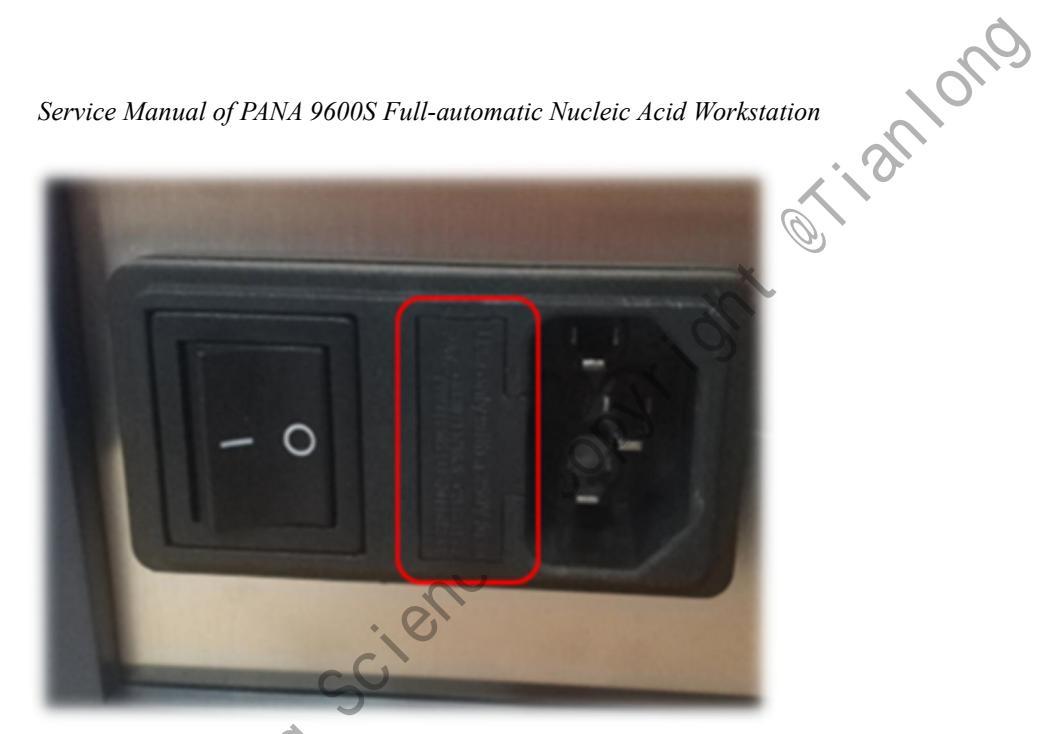
If the power supply is not on normally, remove the fuse box in the power switch and confirm whether the fuse is burnt out. ier Iofianof

Step 4: If the fuse is burnt out, replace the fuse;

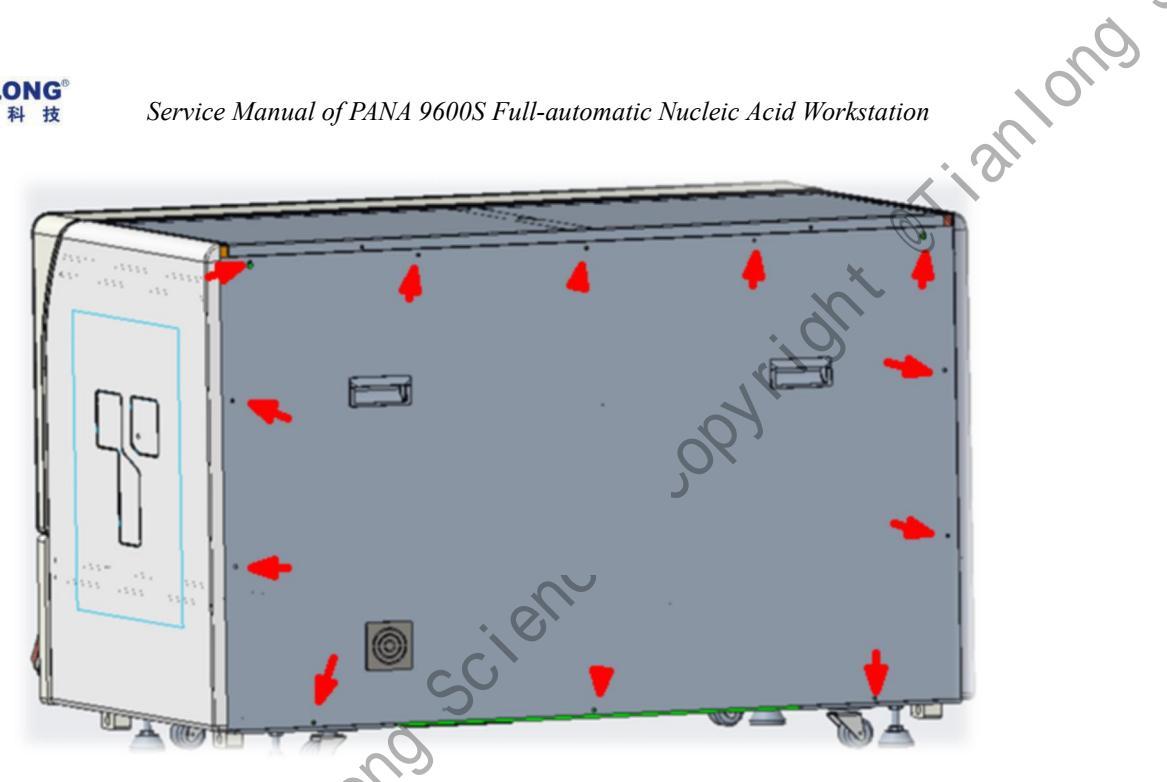
Step 2: Remove the right side plate: remove the 3 fixing screws at the top of the right side plate with M4 internal hexagonal screwdriver, and then remove the right side plate; Visible: industrial control board, refrigeration board, nucleic acid module power board, reagent rack indicator light board, USB board, and refrigeration module.

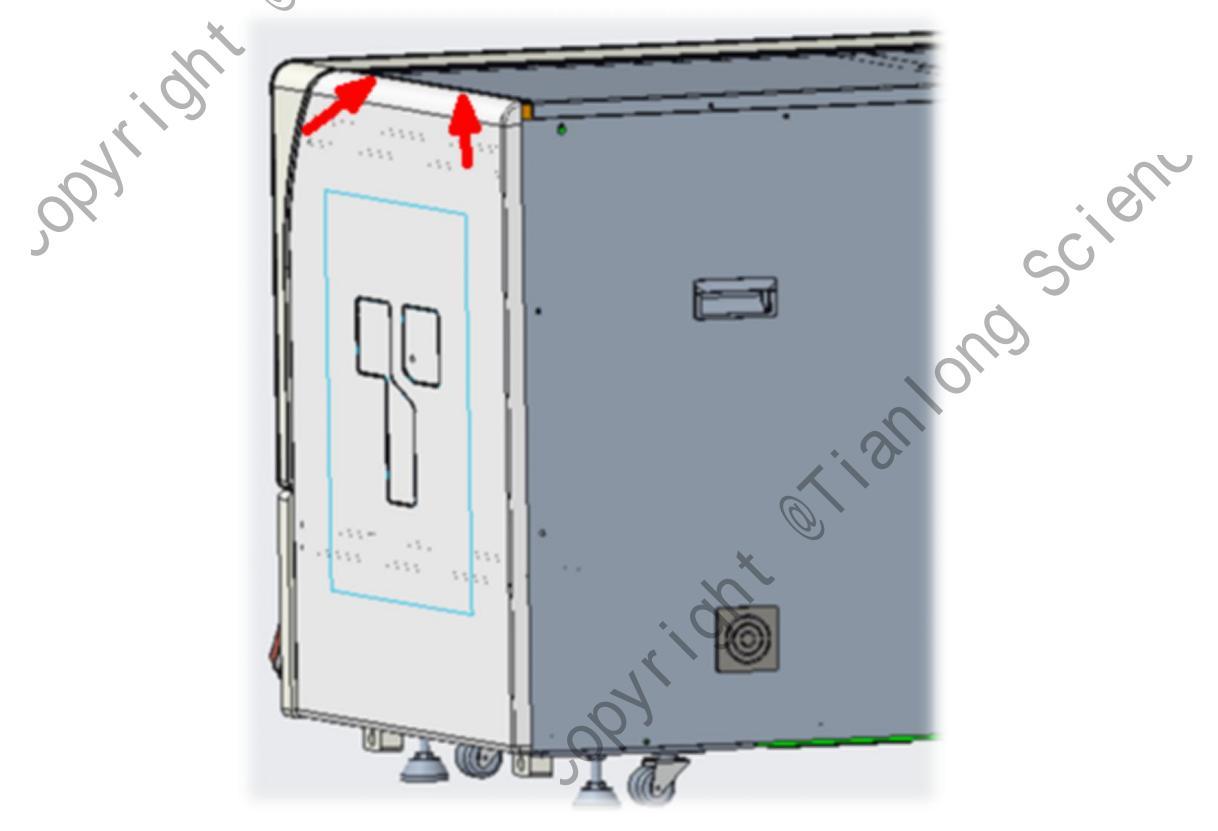
Step 3: Remove the left side plate: use M4 internal hexagonal screwdriver to remove the 3 fixing screws at the top of the left side plate and remove the left side plate; Visible: power indicator light, refrigeration board of status light board, power supply, power rp Atianono Mianono board of pipetting module, X-axis motor driver board, etc.

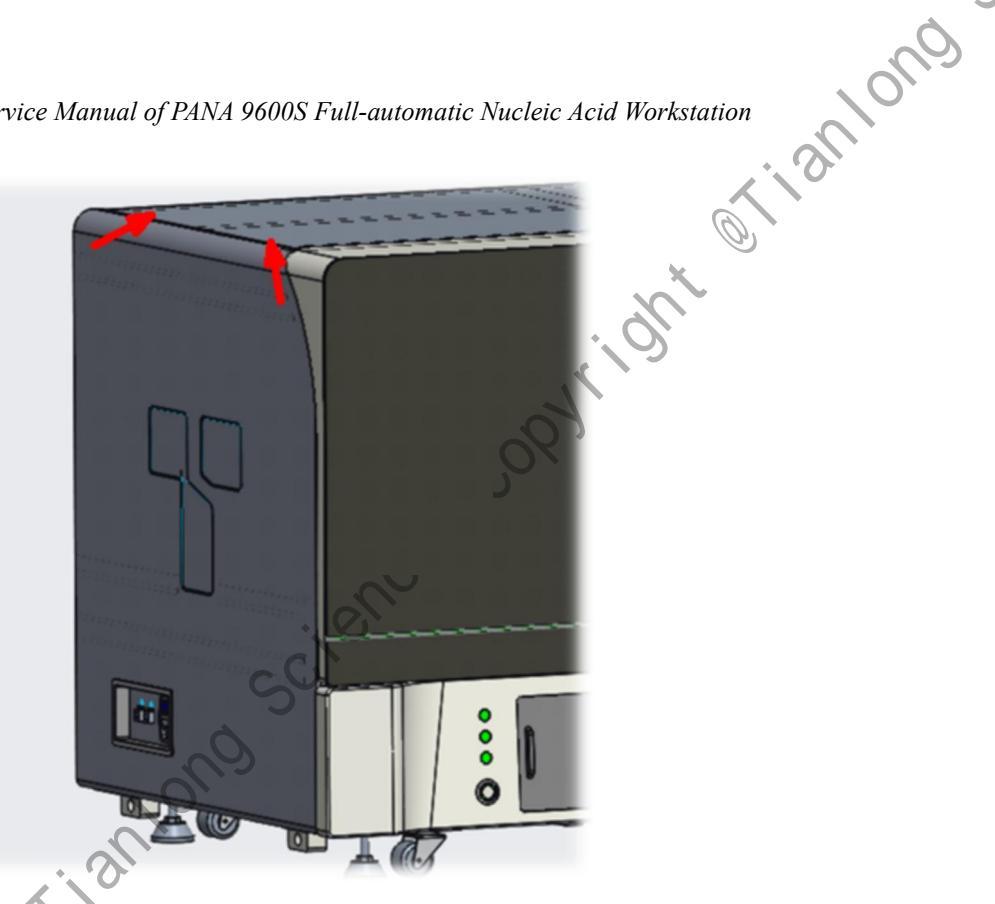
with MZ.5 internal hexagonal screwdriver, and take off the ADP housing; Visible: ADP control board, ADP1-4 biaxial motor driver board, drip motor driver board, camera, 4 ADP, etc.

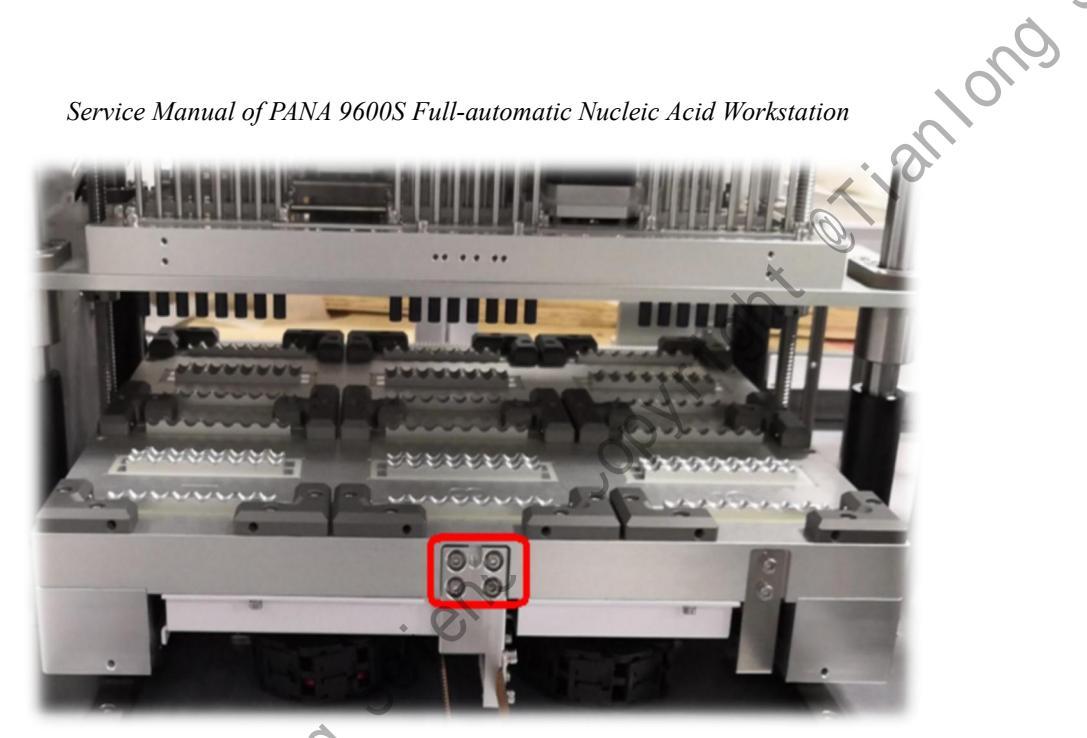
2 Remove the four drag chain fixing plate screws on the right side of the thermal module with M3 internal hexagonal screwdriver;

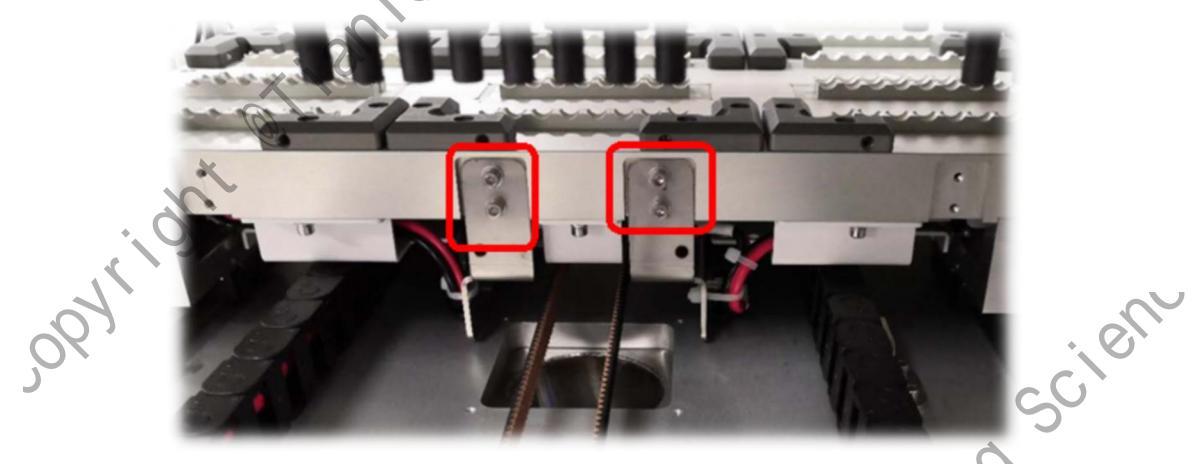
③ Remove the 8 fixing screws above the thermal module with M3 internal hexagonal screwdriver;

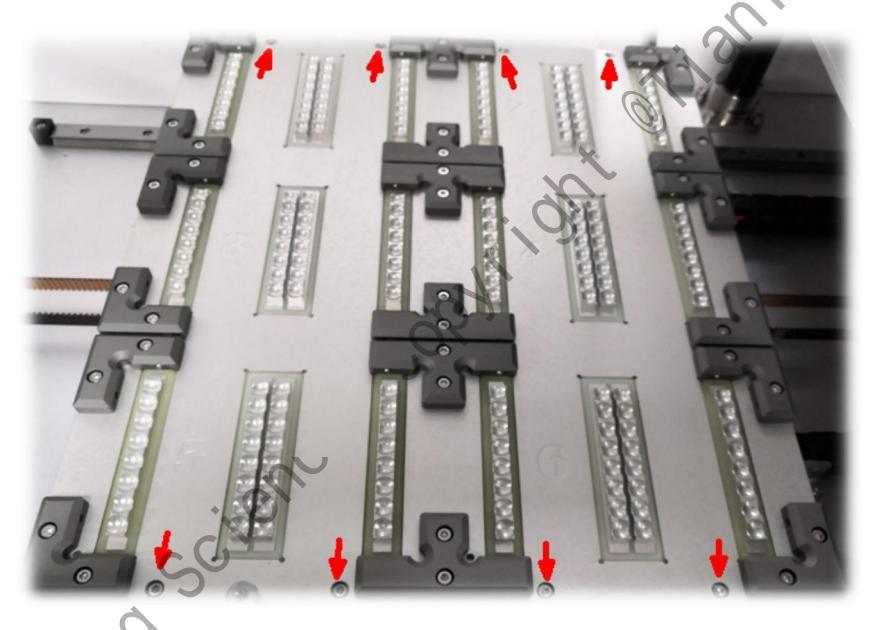
④ After lifting the thermal module, remove the 5 fixable screws on the waterproof board; Visible: 3 thermal control boards and 24 heater strips tial

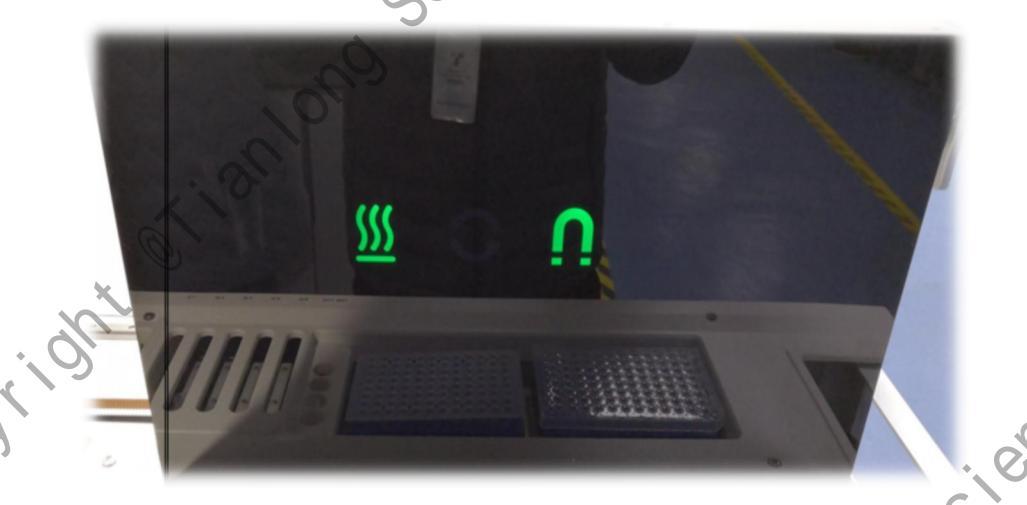
Visible: lifting motor, magnetic motor, horizontal pushing motor, rotary sleeve, magnetic rod, top plate, rotary frame, magnetic frame, etc.

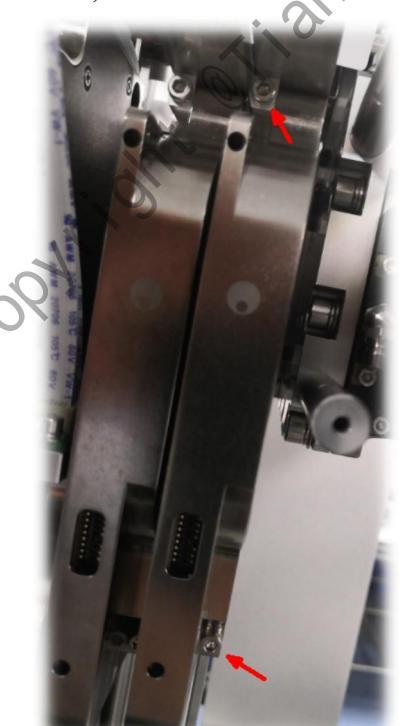
Step 2: Use M3 internal hexagonal screwdriver to remove two screws for fixing ADP, and remove ADP and small board;

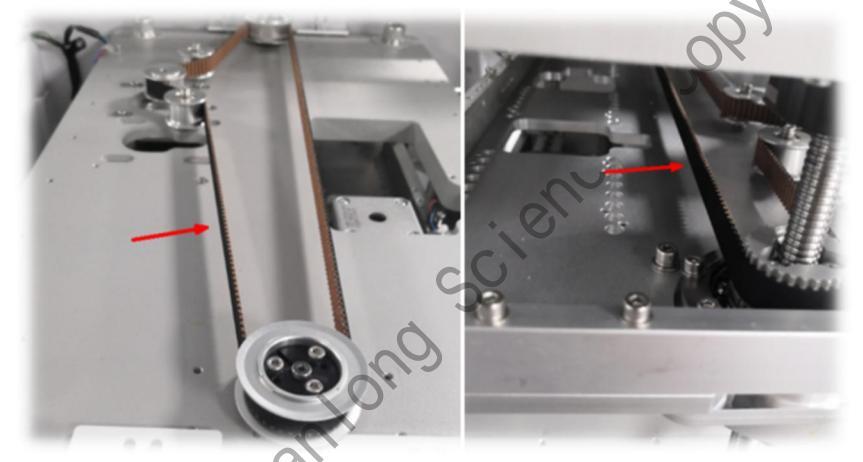
Step 2: Manually rotate the lifting belt and the magnetic belt, and move the rotary frame and the magnetic rod frame to the lowest end;

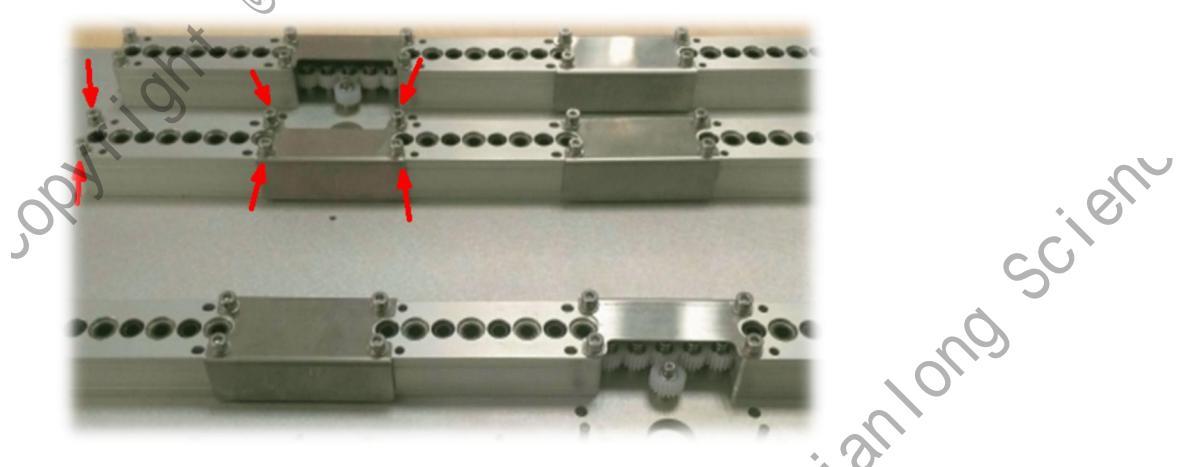
Step 3: Remove the abnormal rotary sleeve and 6 fixing screws of the shielding cover with M3 screwdriver, and take off the shielding cover;

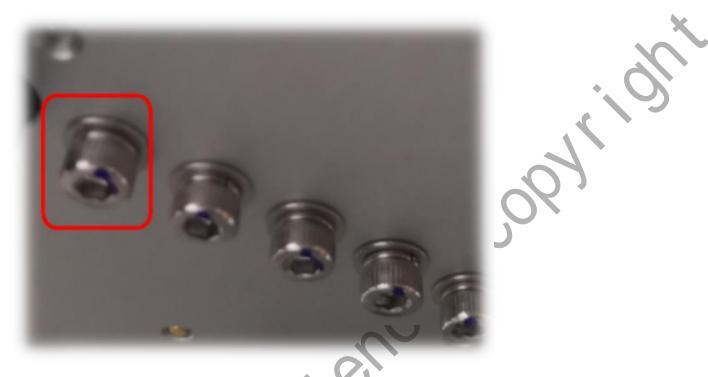
Step 4: on the lower side of the rotary frame, remove 1 gear shaft fixing screw at the edge of the rotary sleeve with abnormal size, and remove the gear shaft and rotary sleeve;

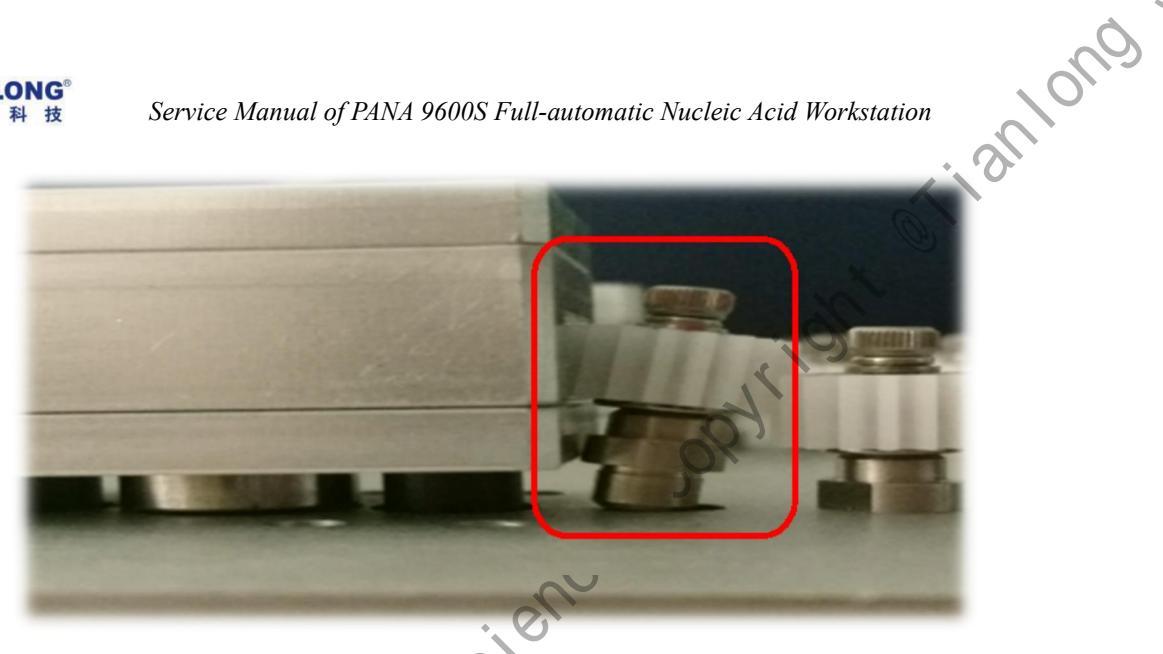
Step 5: Install the  $\phi \Phi 3X30$  pin in the pin hole, then place the rotary sleeve and the adjacent gear shaft on the rotary frame at the same time, and fix the gear shaft from the lower side after leveling; ortianiono

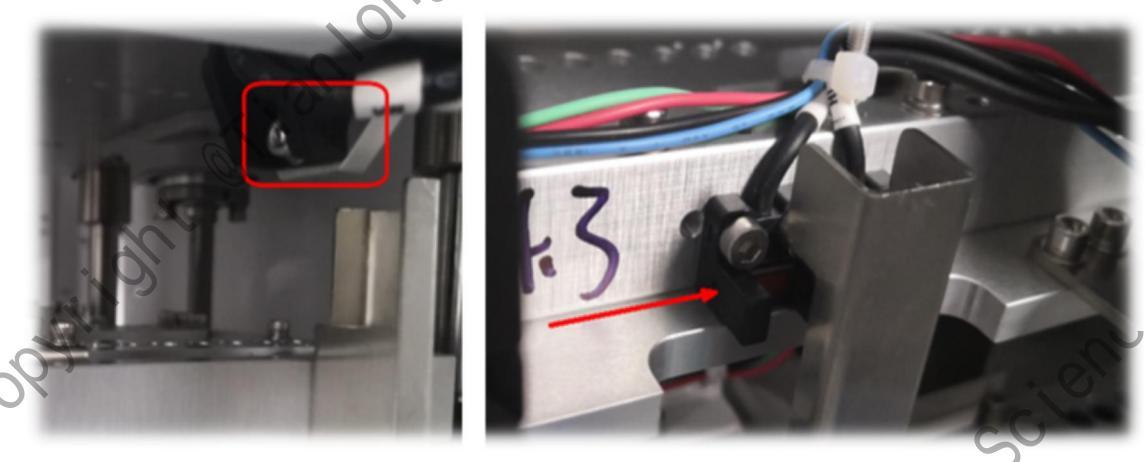
Step 7:Rotate the two belts. Adjust the rotary frame to the upper side of the lifting shielding plate and adjust the magnetic rod frame to the middle position of the magnetic shielding plate.

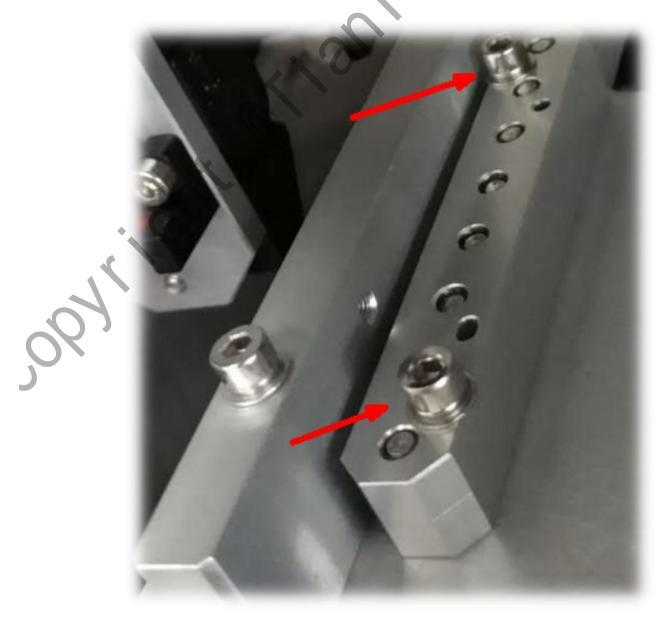
Step 3: Use M3 internal hexagonal screwdriver to remove the abnormal fixing screw of the magnetic rod seat, and take off the magnetic rod seat. The pins should not be lost;

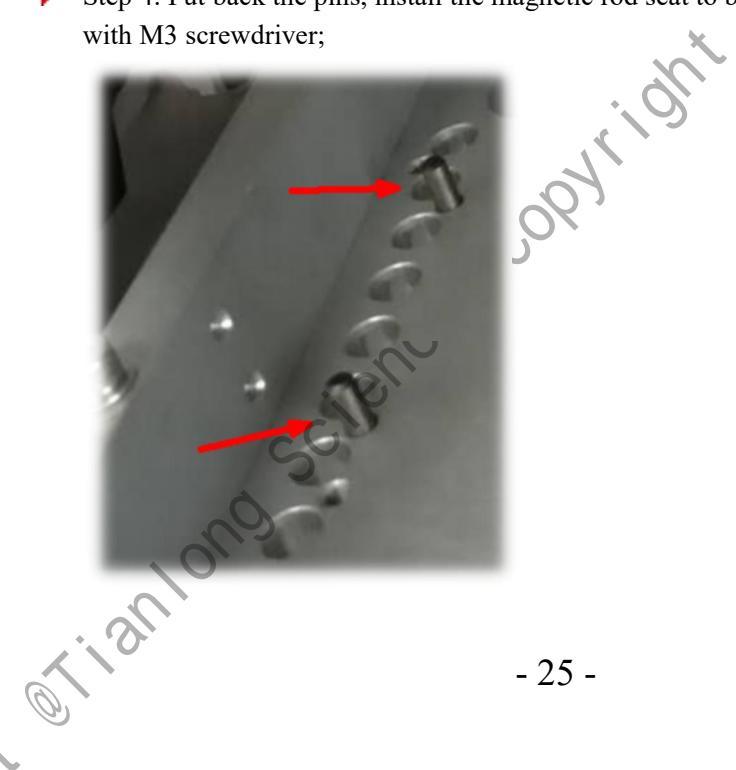
tanlong taced Step 4: Put back the pins, install the magnetic rod seat to be replaced into the instrument, and fix it with M3 screwdriver;

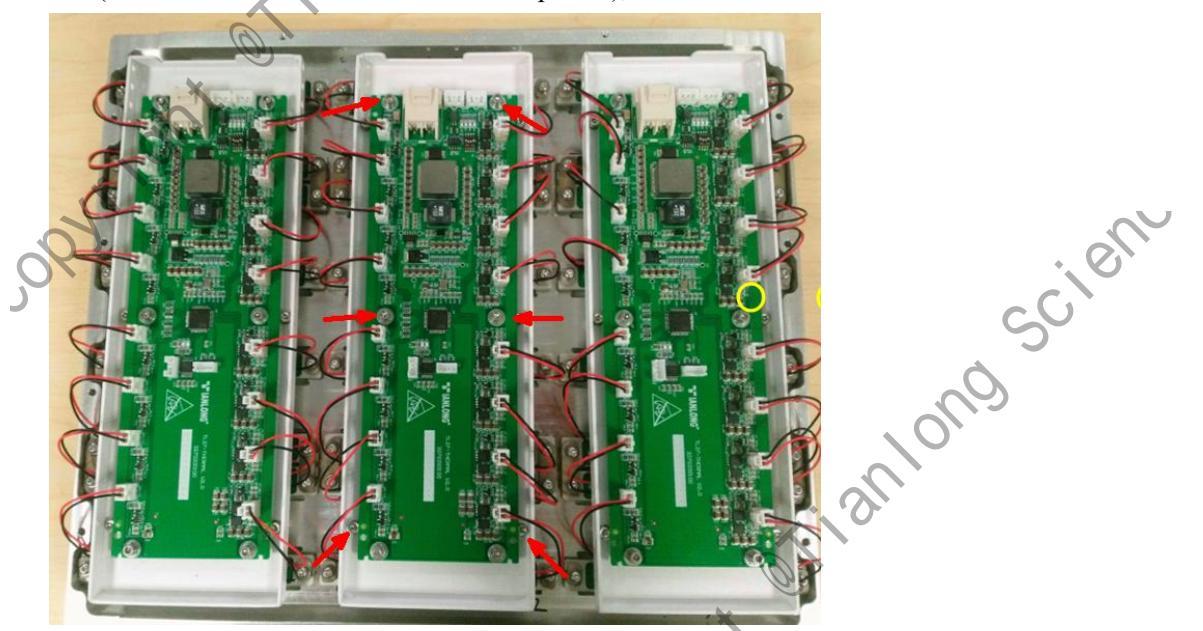
Step 2: Remove the 6 fixing screws on the thermal well plate with M3 screwdriver, and take off the control board (end here if the control board it to be replaced);

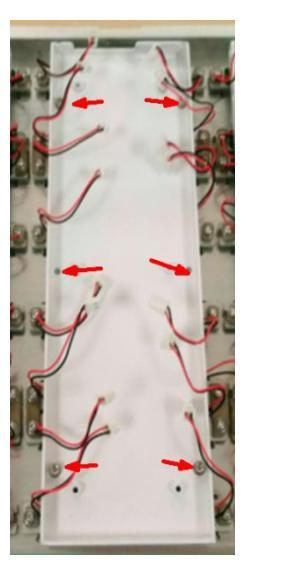
Step 3: Remove the 6 fixing screws on the waterproof plate with M3 screwdriver. After removing the waterproof plate, the heater strip can be seen; opti

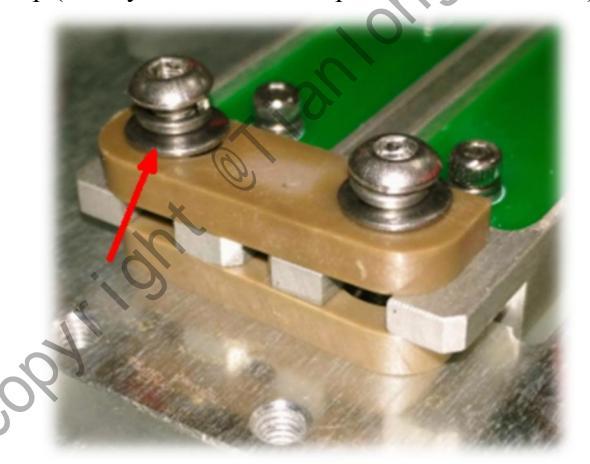
Step 4: Remove 2 fixing screws of heating strip with M3 screwdriver, and complete the replacement of heater strip (mainly in the insulation pad and wire direction);

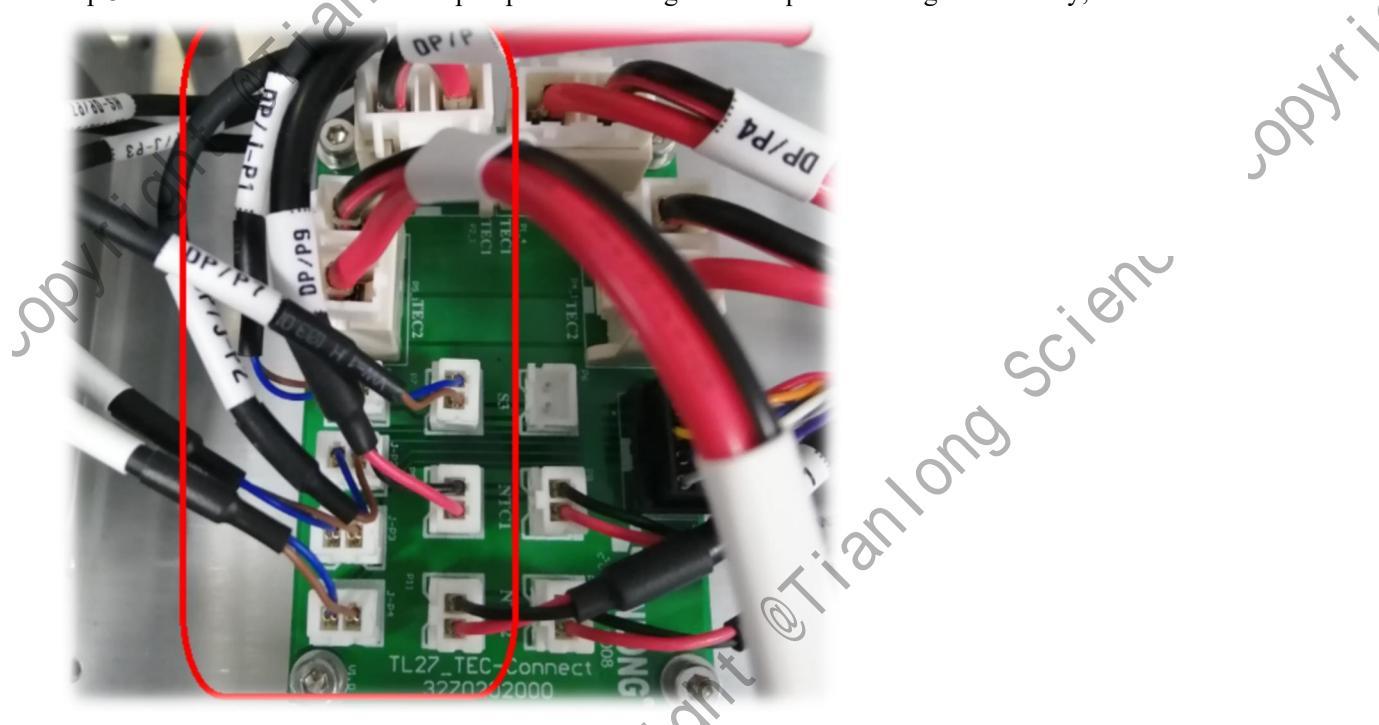
Step 3: Connect all wires on the adapter plate according to the sequence during disassembly;

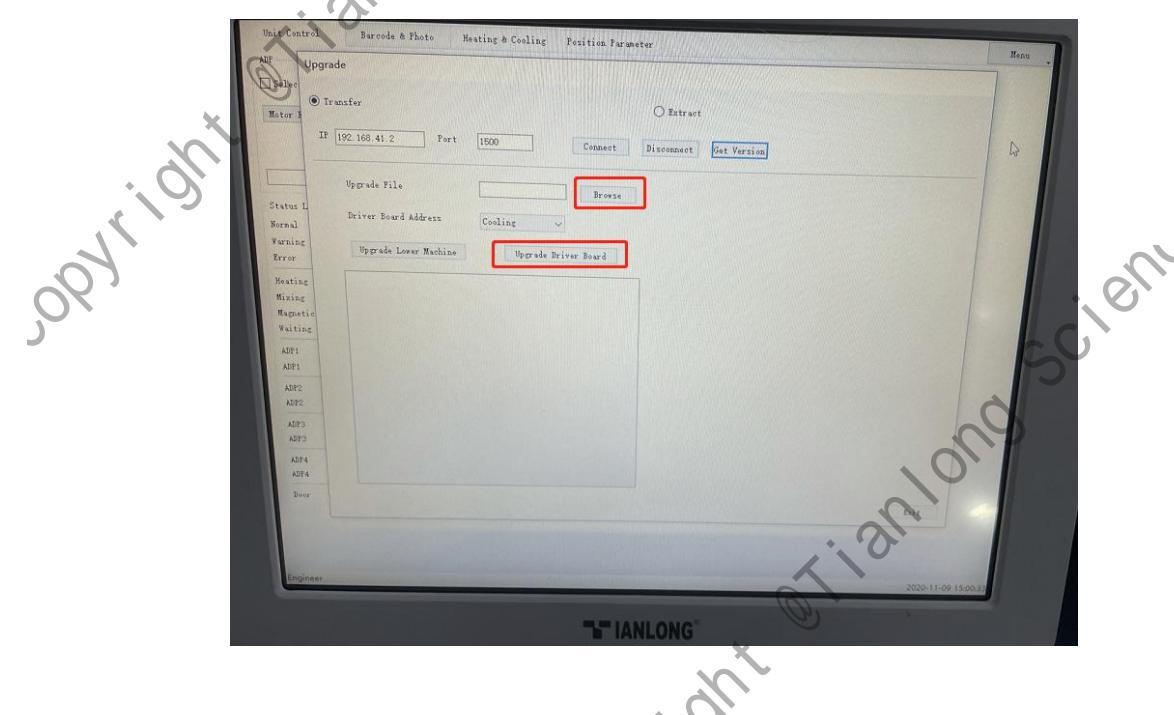
Step 4: Upgrade the middle computer, click the "Browse" button, select the upgrade file, and then click the "Upgrade Middle Computer" button to complete the upgrade. Before upgrade, the refrigeration module must be closed, otherwise there will be risk of upgrade failure;

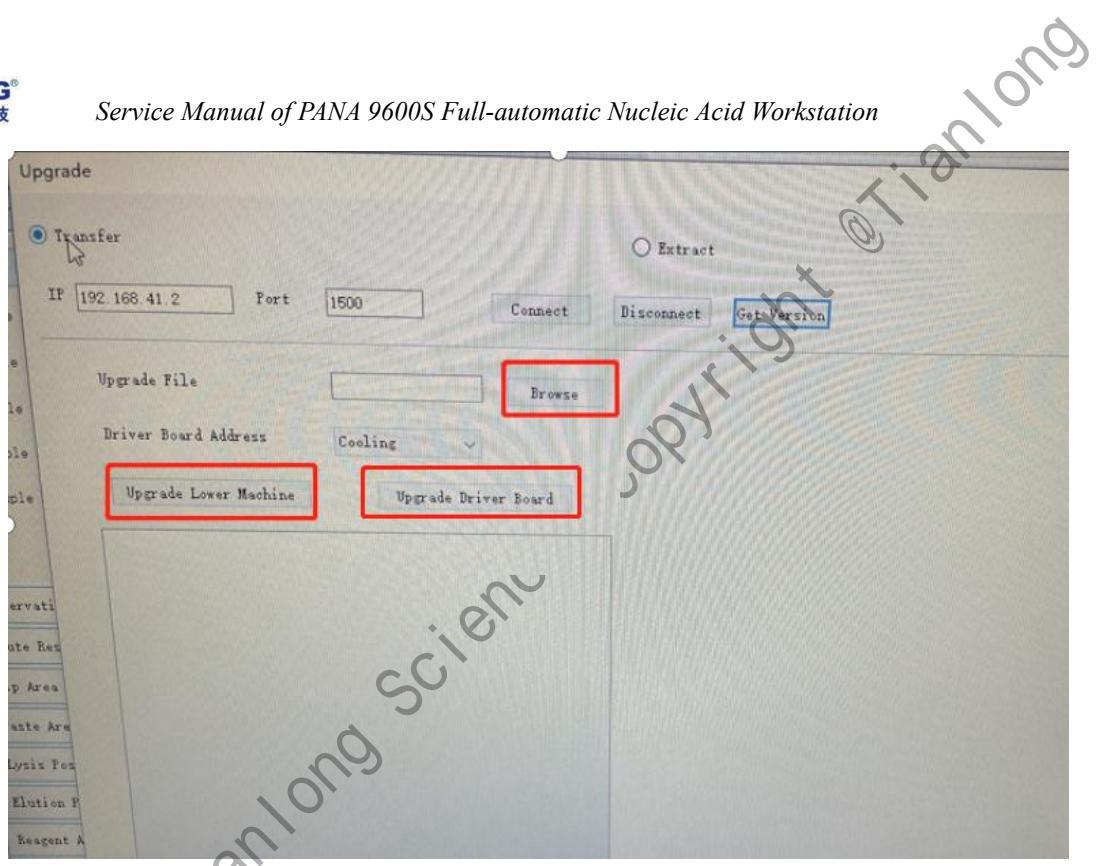
Step 5: Upgrade the lower computer: click the "Browse" button, select the corresponding "Lower Computer Address" and then click the "Upgrade" button to complete the upgrade;
