Report number: HGCJ190804001

TEST REPORT

Sample Description: NANO SINK

Test Type: Internal Inspection

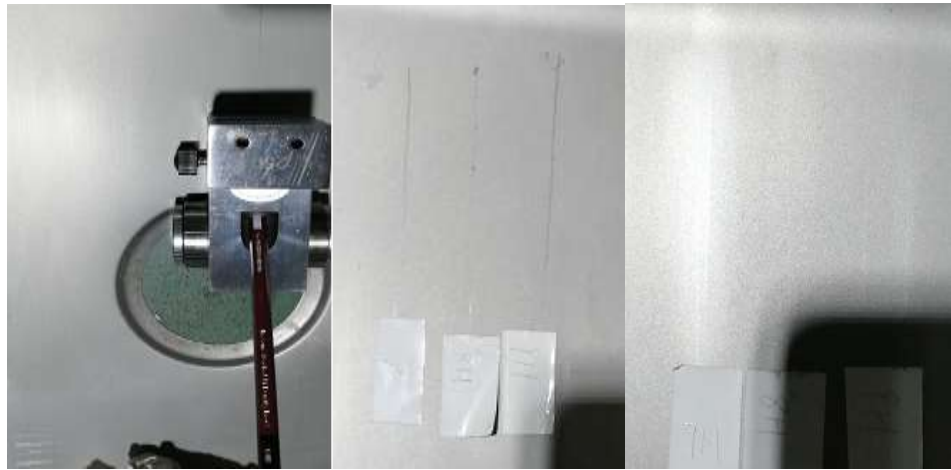
| Test Item | Test Process Photo | Result |
|---|---|---|
| Pencil hardness test | <p>Three photographs showing the pencil hardness test process. The first shows the testing equipment. The second shows the test surface with pencil marks. The third shows the test surface after the test.</p> | Qualified |

| No. | Inspection Item | Inspection Basis and Requirements | Terms | Test Results | Analysis and Judgment |
|---|---|---|---|--|---|
| 7 | Pencil hardness test | A set of pencils with a pencil (hardness 4H-9H) is cut, that is, one end of the wood is cut about 5mm ~ 6mm, carefully operated to leave the original, unscratched, smooth cylindrical pencil refill (as shown in picture 2). The used pencil tip can be flattened (at a right angle) on the sandpaper (grain size 400), and the edge of the refilled core is free of debris and notches at a 45 °angle to align the tip to the surface of the workpiece being tested. Next, a straight line segment distance of at least 7 mm is pushed toward the front (in the direction away from the operator) by a force (about 750 g load force) at a speed of 0.5 mm/s to 1 mm/s. The hardness is increased sequentially by 4H-9H until a scratch of at least 3 mm is present. After 30 seconds, the pencil marks on the workpiece are wiped clean with a soft cloth or an eraser. The hardness of the coating is expressed by the hardness of the hardest pencil which does not cause scratches of 3 mm or more on the plating film. If the pencil with the lower hardness is not scratched on the workpiece to be tested, and the pencil with the higher hardness is scratched, the hardness of the workpiece to be tested is the hardness of the pencil of the lower level, such as the 2H pencil is not scratched, and If the 3H pencil is scratched, the hardness of the workpiece coating is 2H. | 10.9 | 9H | Qualified |

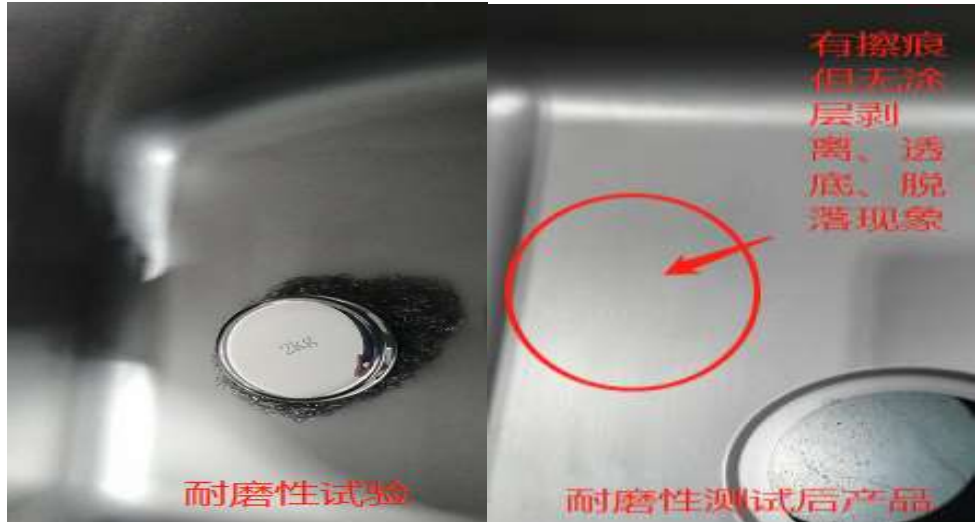
| Test Item | Test Process Photo | Result |
|---|---|---|
| Abrasion resistance test | <p>Two photographs showing the abrasion resistance test. The left photo shows the test equipment with the text "耐磨性试验" (Abrasion resistance test). The right photo shows the product after the test with a red circle highlighting a mark and the text "有擦痕 但未涂层剥离、透底、脱落现象" (There are scratches but no coating peeling, bottom penetration, or falling off phenomenon) and "耐磨性测试后产品" (Product after abrasion resistance test).</p> | Qualified |

| No. | Inspection Item | Inspection Basis and Requirements | Terms | Test Results | Analysis and Judgment |
|---|---|---|---|--|---|
| 8 | Abrasion resistance test | Rubbing with a steel ball, applying 20N force at a 45-degree oblique angle, rubbing back and forth once for one cycle, testing a total of 10 cycles, the coating should not be destroyed, and peeling, bubbles, and wrinkles should not occur. | 10.10 | Slight scratches but no peel, bubbles, wrinkling phenomenon | Qualified |

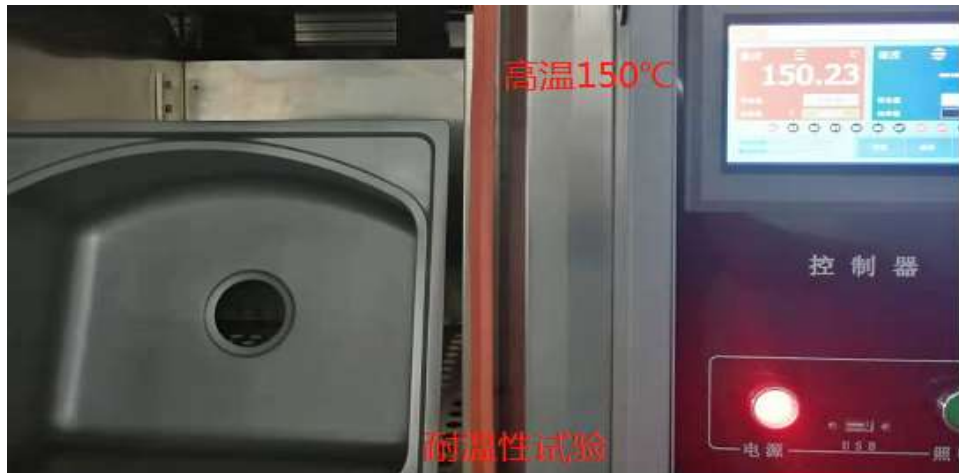
| Test Item | Test Process Photo | Result |
|---|---|---|
| Temperature resistance test | <p>Two photographs showing the temperature resistance test. The left photo shows the sink being tested with the text "耐高温试验" (High temperature resistance test). The right photo shows the control panel of the testing chamber with a digital display showing "150.23" and the text "高温150℃" (High temperature 150°C) and "控制器" (Controller).</p> | Qualified |

| No. | Inspection Item | Inspection Basis and Requirements | Terms | Test Results | Analysis and Judgment |
|---|---|---|---|--|---|
| 9 | Temperature resistance test | 1) High temperature resistance: high temperature 150 °C insulation 2 H no yellowing, blackening, coating cannot appear peeling, foaming, wrinkling. 2) Low temperature resistance: 24H stored at a low temperature of -20 degrees, the coating should not be peeled, foamed or wrinkled. | 10.11 | Yellowing, blackening, no peeling, blistering, wrinkling of the coating. | Qualified |

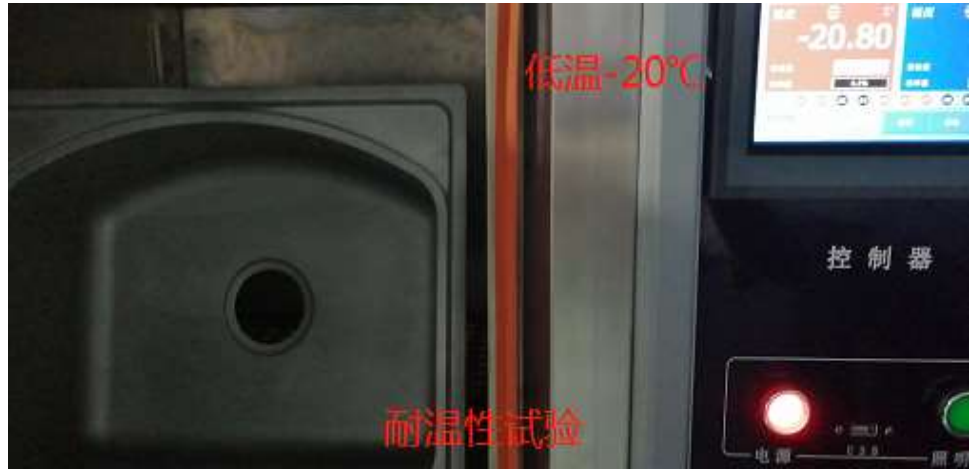
| Test Item | Test Process Photo | Result |
|--|---|---|
| <p>Temperature resistance test</p> | <p style="color: red; font-weight: bold;">低温-20°C</p> <p style="color: red; font-weight: bold;">耐温性试验</p> | <p>Qualified</p> |

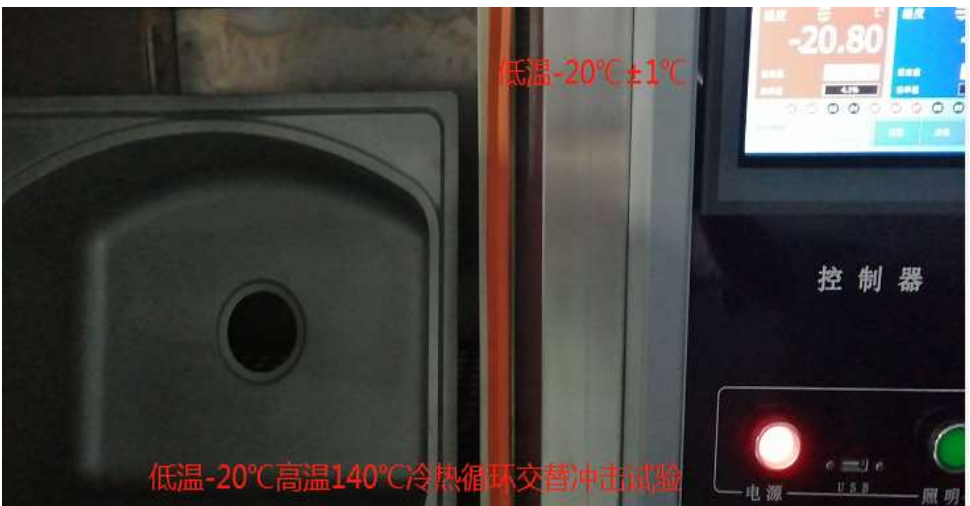
| Test Item | Test Process Photo | Result |
|--|---|---|
| <p>Thermal shock test</p> | <p style="color: red; font-weight: bold;">低温-20°C ± 1°C</p> <p style="color: red; font-weight: bold;">低温-20°C 高温140°C 冷热循环交替冲击试验</p> | <p>Qualified</p> |

| No. | Inspection Item | Inspection Basis and Requirements | Terms | Test Results | Analysis and Judgment |
|---|---|---|---|--|---|
| 10 | Resistance to weather fastness test | The metal nano-products were placed in a constant temperature and humidity at -20 °C ± 1 °C for 2 hours, then rapidly transferred to 140 °C ± 1 °C for 2 hours for a test cycle, continuous 32 cycles of thermal cycle impact test, The coating should not peel, blister or wrinkle. | 10.12 | The coating did not show peeling, foaming, and wrinkling. | Qualified |

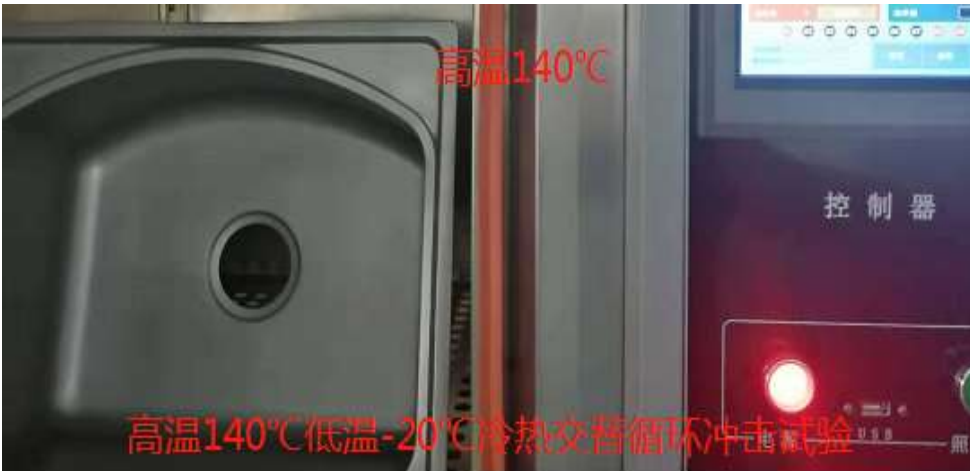
| Test Item | Test Process Photo | Result |
|--|---|---|
| <p>Resistance to weather fastness test</p> | <p style="color: red; font-weight: bold;">高温140°C</p> <p style="color: red; font-weight: bold;">高温140°C 低温-20°C 冷热交替循环冲击试验</p> | <p>Qualified</p> |
