Leada New Material Co., Ltd.

PAINT DEFECT TYPES

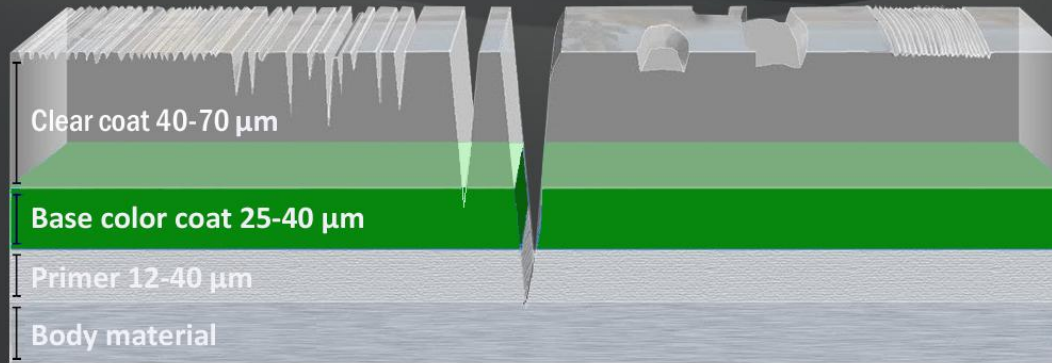
Swirls/
light scratches

Random Scratches

Car key marks
deep scratches

Water / Acid
Rain Etching

Buffer Marks
Holograms

Metric Measurement: 1 Micron (μm) = 1/1000 mm

- * Random Scratch: #4500 + Wool Pad
#4500 + Foam polish Pad
(2 steps in 1)
- * Deep Scratch: #8300P + Foam Cutting Pad
- * Swirls/hologram: #9000 + Foam Final Pad

If clear coat has been penetrated and can only be fully repaired by repainting.
